From the field: A professional's observations

Following are comments based on evaluations of various roof systems

by **Rene M. Dupuis, Ph.D., PE**

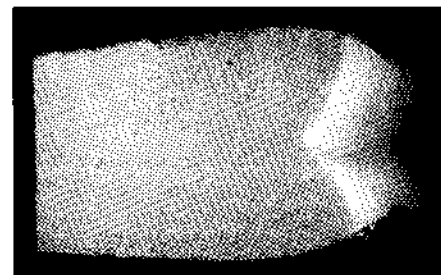
Edge view of 3-inch-thick (76-mm-thick) polyisocyanurate foam insulation board showing cavitation. The sample was taken from a roof less than 6 months old.

Recently, there have been a few field problems reported with newly installed polyisocyanurate insulation. The insulation boards are showing a collapsing or cavitation-type behavior at the edge of the board; there may also be related shrinkage.

When a single-ply membrane is installed, the contractor begins to notice that the single-ply membrane in the area of the insulation board joints seems to be collapsing or trapping water if it has recently rained. This behavior has been noted on a few jobs throughout the United States; the age of the problem jobs reported ranges from 3 days to 3 months.

There are several theories as to why this is happening, and some of it may be related to the change in blowing agents that has taken place in manu-

If you are installing new insulation board and it appears that the machine edge of the insulation board has collapsed slightly or looks less than square, it is probably best to take a closer look at the material. Keep the inventory stored as close to warehouse conditions as possible, and retain several boards in the warehouse for future reference in the event a dimensional stability problem occurs.

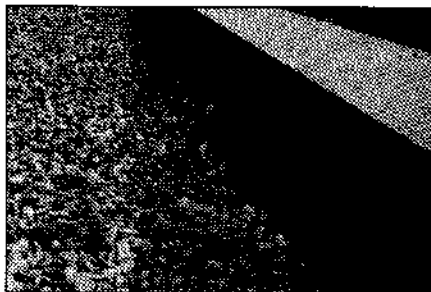
By comparison, no other membrane has ever come into such wide use without experiencing weathering problems as a material; it almost seemed as if EPDM itself was immune from any material problem. However, a number of EPDM roofs are now experiencing shrinkage problems. The shrinkage problem is sometimes referred to as tenting or contraction by manufacturers. If the problem exists, it can readily be seen

at points of perimeter flashing or parapet wall attachment. The occurrence is not uniform and may be related to a number of sheets, showing a lifting or tenting away from the point of attachment. Essentially, the membrane is tightening up, thus causing a pulling away action.

There are a number of factors that may contribute to the shrinkage, ranging from manufacturing to relaxation time allowed on the roof before installation. If the tenting or bridging along the roof edge is more than 3 feet (1 m) long and the membrane has pulled away more than 2 inches (50 mm) from the wall, repairs should be made. The shrinkage forces may not be significant; the debate continues on whether the shrinkage or contraction ever stops or whether it diminishes with time.

View of 9-year-old ballast 45 mil (1 mm) EPDM, showing 8 inches (203 mm) of tenting because of shrinkage.

Some of the tenting problems may in fact be due to poor attachment at the wall. If poor attachment exists, then the first order of business is to establish a good anchorment.
