Highlights of NRF's SPF roof system study released

Roofing professional provides insight into SPF research project

by Rene M. Dupuis

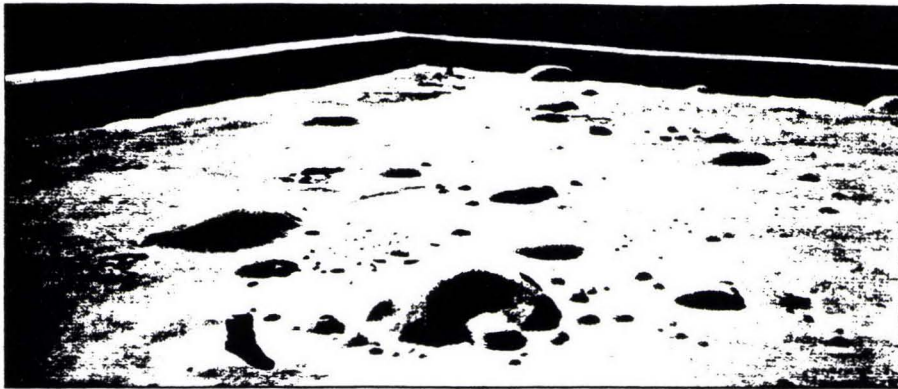
Photo 2: This roof system has several blisters, some of which are relatively large. Most of them have not ruptured. Although this is not an attractive roof system, it still is functional. SPF was applied over an aggregate-surfaced BUR.

Foam blisters were observed on

a number of SPF roof systems (see Photo 2). Similar to small blisters found on BURs, they typically are left alone. If they are cracked or ruptured, they eventually should be repaired.

However, as with mechanical damage, upon rupturing, a roof system typically is not vulnerable to leakage

for a substantial length of time. Blisters typically occur between lifts (applications) of foam; therefore, if the blister ruptures, leakage protection is provided by the lower lift(s) of foam. Blisters also may occur between the coating and foam.

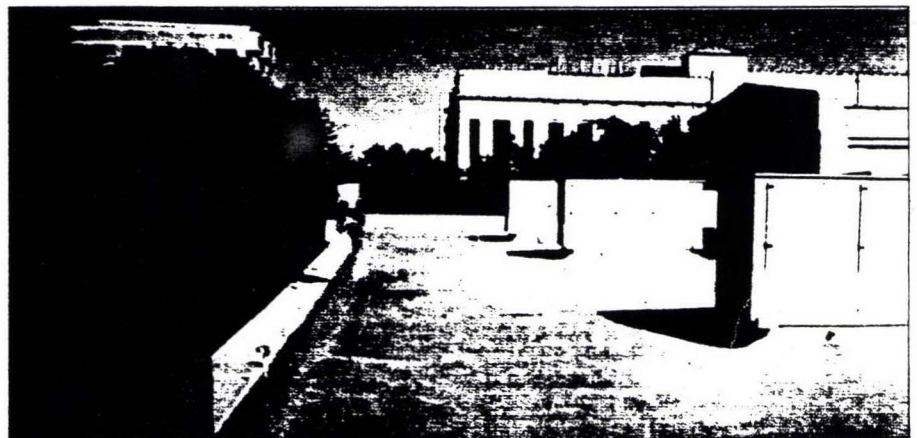
Granule surfacings now often are included at the rate of 40 pounds per square (2 kg/m²). They vastly diminish bird damage problems and improve a roof system's appearance (see Photo 3). Aggregate-surfaced SPF roof systems use 400 to 500 pounds per square (20 to 24 kg/m²) of aggregate laid over uncoated foam.

Photo 3: This SPF roof system is surfaced with light-brown granules, which present a relatively attractive appearance. SPF was applied over a smooth-surfaced BUR in 1978; in 1995, the SPF was scarfed and recoated. This photo was taken in 1996.
