# APP and SBS Modified Bitumen Membrane Roofs:

A Survey  
of Field  
Performance

MIDWEST ROOFING  
CONTRACTORS  
ASSOCIATION, INC.

NATIONAL  
ROOFING  
CONTRACTORS  
ASSOCIATION

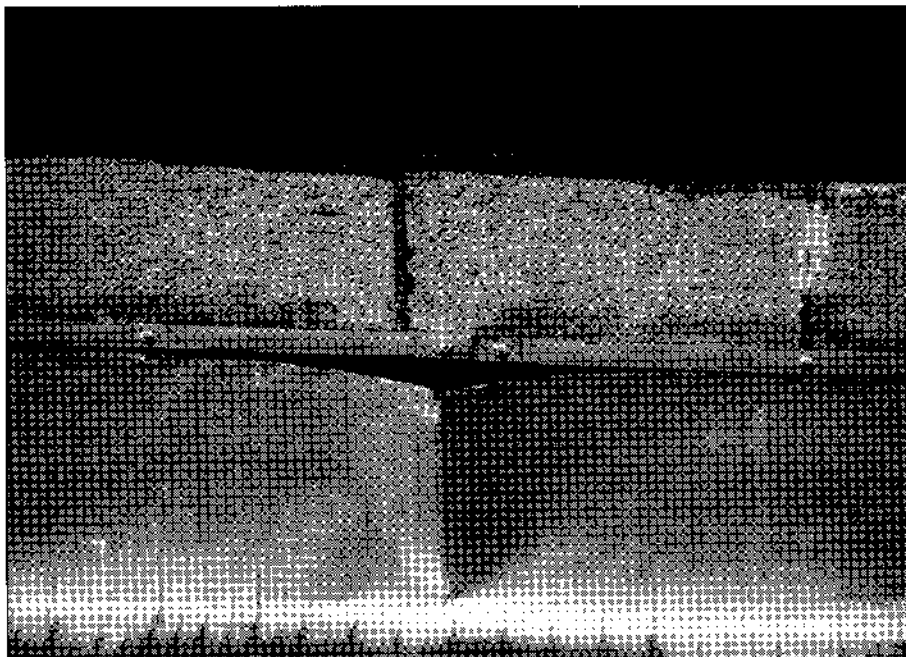
**Counterflashings:** On some jobs, the top of the base flashing was terminated with a metal termination bar, as is commonly used to terminate single-ply membrane base flashings. In a few instances, the base flashing sheet pulled out from underneath the termination bar (Photo 2), thereby allowing rainwater to enter the flashing assembly.

**Photo 2.** Roof 7E: The metal foil surfaced APP modified bitumen base flashing pulled out from underneath the metal termination bar. The bar's fasteners were spaced too far apart and placed too close to the top of the sheet. This eight-year-old roof is located in Chicago.

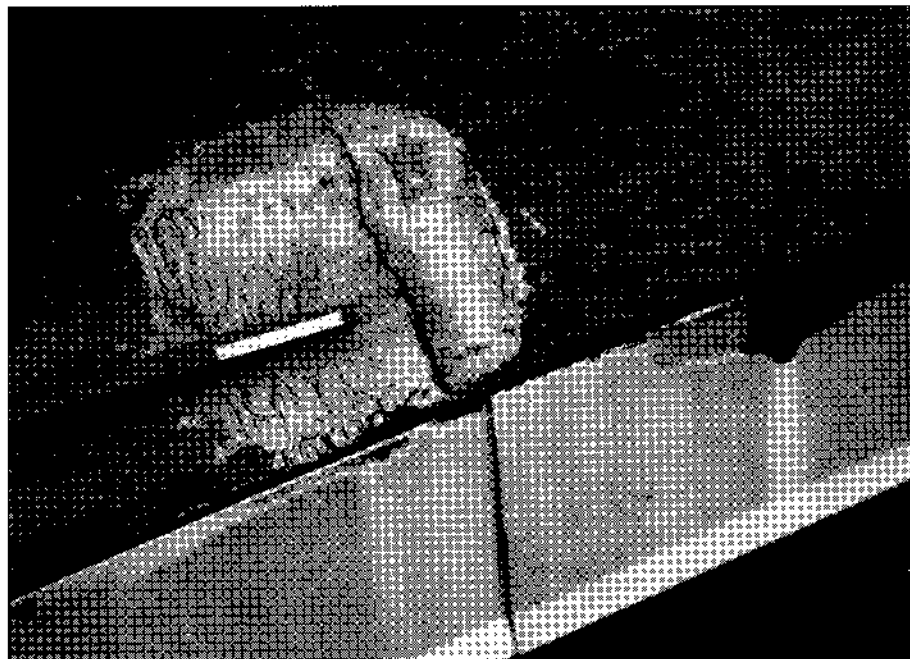
**Metal Edge Flashings:** Membrane splits at metal edge flashing joints were observed on several of the roofs in this survey (Photo 3). This type of problem is also often experienced with built-up roofs. It is typically caused by excessive movement of the metal, which is caused by insufficient nailing of the metal edge flashing (either due to a deficient nailing specification or due to failure to follow the specification).

**Photo 3.** Roof 54A: The APP modified bitumen membrane split at the metal edge flashing expansion joint. Note that the metal flashing was placed underneath the cap sheet. This eight-year-old roof is located in New Orleans.

It was observed that the metal edge flashings on several of the roofs were constructed without a stripping ply (i.e., the metal edge flashing was installed prior to the application of the membrane, as shown in Photos 3 and 4). (This condition could be attributable to the design of the detail, or failure to follow the design.) When the metal edge flashing is underneath the membrane, the membrane may be vulnerable to wind blow-off, since the edge of the membrane is not continuously clamped down. If there is a fishmouth at the edge, or if the membrane becomes separated from the metal (Photo 4), the membrane will be susceptible to lifting and peeling, which can lead to a large progressive failure. By detailing the metal over the membrane, followed by a stripping ply (as shown in *The NRCA Roofing and Waterproofing Manual*), in addition to providing enhanced wind-resistance, the roof edge is also less prone to leakage.

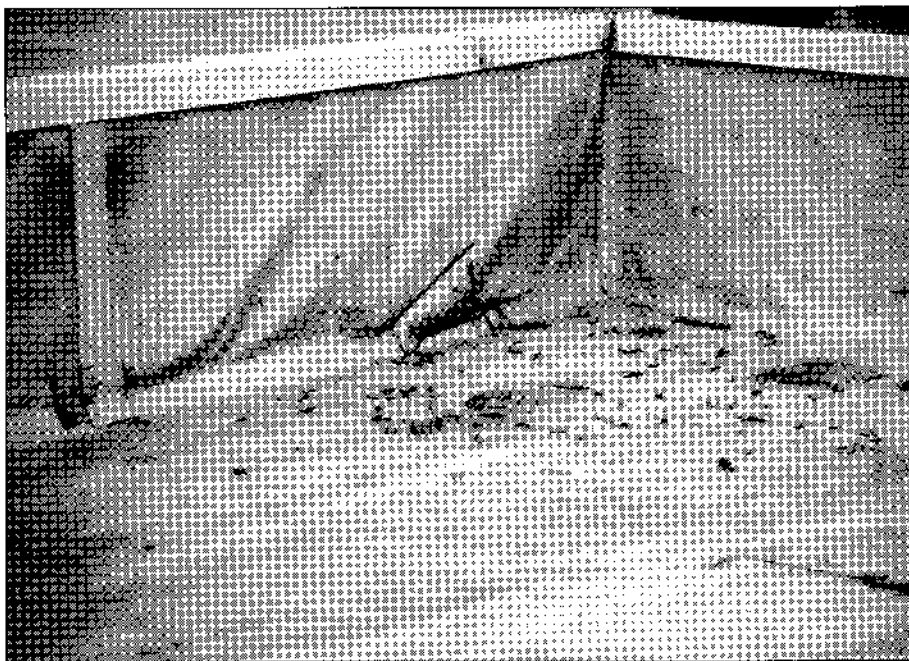
Diagonal wrinkling was associated with many of these problems (Photo 5). The cracked base flashings typically occurred at wrinkled areas, as shown in Photo 5. Some of the cracks appeared to extend through the wrinkled sheet.

**Photo 5.** Roof 61: APP modified bitumen base flashing has separated from the parapet. The diagonal wrinkles are indicative of differential movement between the parapet and the roof deck. In several areas near the ink pen, the flashing is severely cracked. This five-year-old roof is located in New Orleans.

Diagonal wrinkling is typically associated with differential movement between the parapet and the roof deck.<sup>18</sup> Differential movement can be caused by thermal movements or live loads (e.g., snow). The intersection between the deck and parapet (or wall) needs to be designed and constructed to avoid differential movement, or an expansion joint needs to be designed for this intersection.

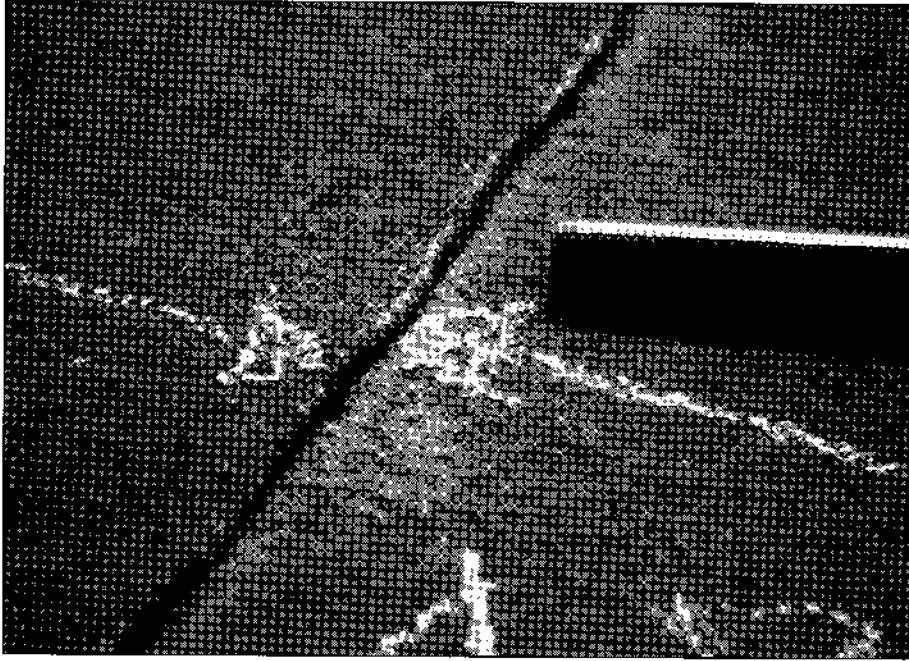
**Single-Layer Installations:** Some of the observed roof membranes were found to be a true single-layer (single-ply) configuration. On some of these roofs, movement of the rigid insulation board due to thermal loads or dimensional instability apparently caused the membrane to ridge at some of the underlying insulation board joints. At Roof 4B, the membrane was overriding itself and becoming vulnerable to rupturing (Photo 6).

**Photo 6.** Roof 4B: Ridging of an APP modified bitumen membrane composed of a single-layer is shown. The membrane on one side of the ridge line is riding up over the membrane on the other side. The ridge line has become vulnerable to rupturing. This seven-year-old roof is located in Chicago.

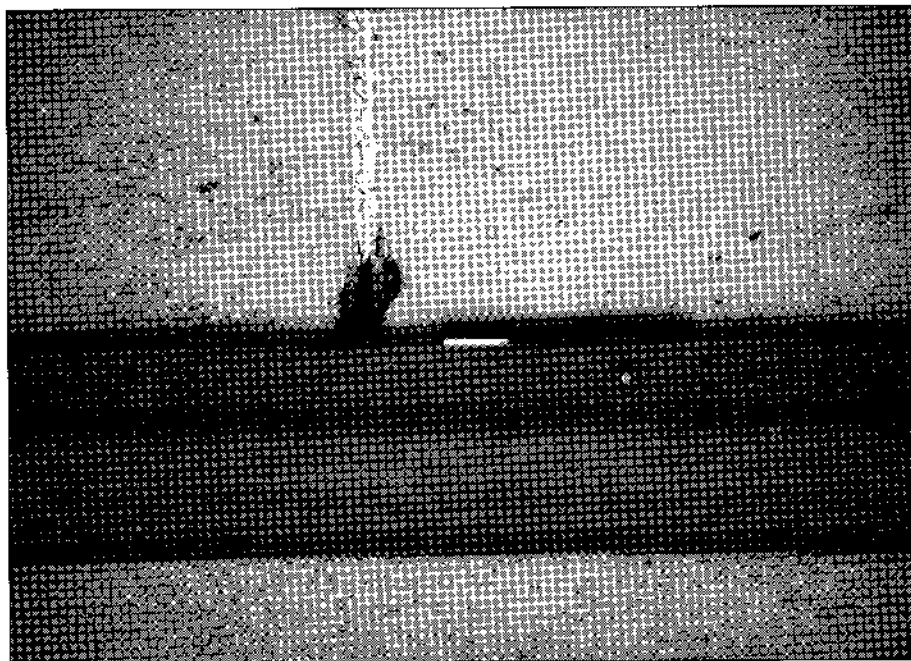
**Surface-Mounted Reglets and Counterflashing:** Some of the roofs used surface-mounted reglets and counterflashings on parapets. Photo 7 shows a surfaced-mounted reglet crossing a vertical sealant joint. As this detail ages, it becomes very prone to water infiltration, although the amount of water that can flow in is relatively small. Similarly, infiltration can occur at the intersection of masonry mortar joints and termination bars (Photo 2).

**Photo 7.** Roof 15A: A surface-mounted reglet and counterflashing crossing a vertical sealant joint in a parapet wall is shown. The intersection of the vertical and horizontal sealant joints can become vulnerable to water infiltration. Note the cracking of the vertical sealant joint. This two-year-old roof is located in Kansas City.

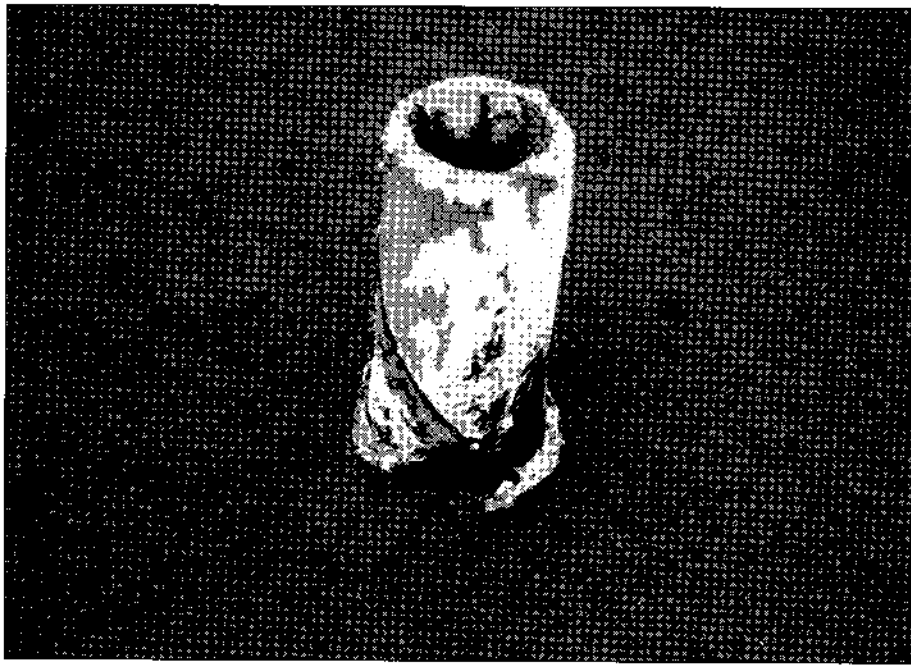
**Vent-Through-Roof (VTR):** Some VTR (plumbing vent) details were observed wherein the lead flashing flange was placed underneath the cap sheet (Photo 8). To install this detail, the modified bitumen cap sheet usually needs to have cuts radiating out from the hole for the pipe. As the detail ages, it becomes vulnerable to water penetrating past the cap sheet, since the cuts are only sealed by the mopping asphalt, cold adhesive or bitumen that flowed upon heating as the cap sheet was set.

**Photo 8.** Roof 56: The lead VTR flashing flange was placed below the SBS modified bitumen cap sheet. The membrane is beginning to lift at one of the radial cuts. This problem can be avoided by placing the metal flange over the cap sheet, followed by a stripping ply. This ten-year-old roof is located in New Orleans.

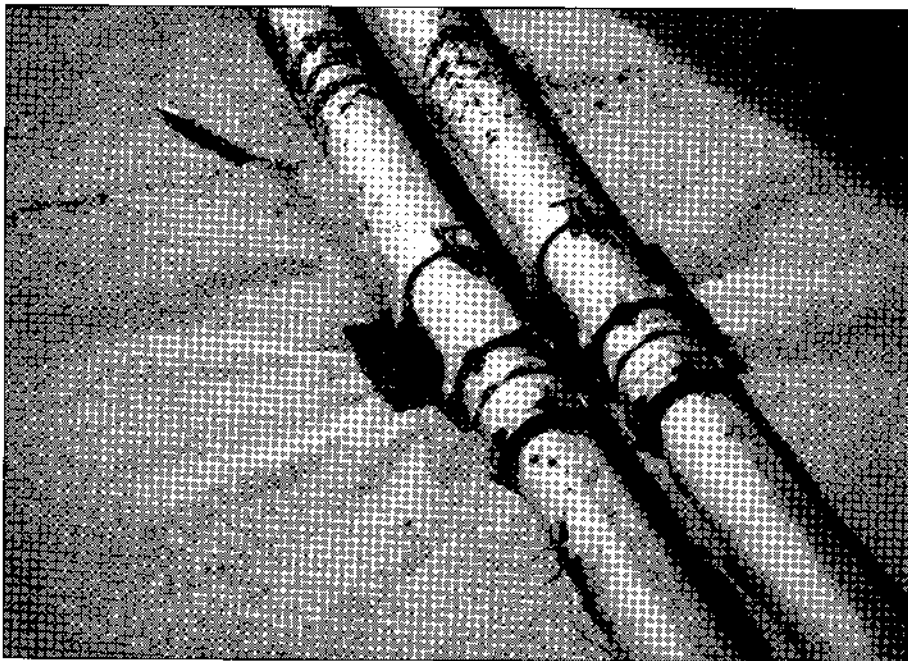
**Photo 9.** Roof 26: Heavy conduits are inadequately supported on this SBS modified bitumen membrane. The insulation has been crushed and a fishmouth occurs at the endlap (an ink pen extends into the open lap). Over time, membrane leakage near the supports may occur. This one-year-old roof is located in Phoenix.

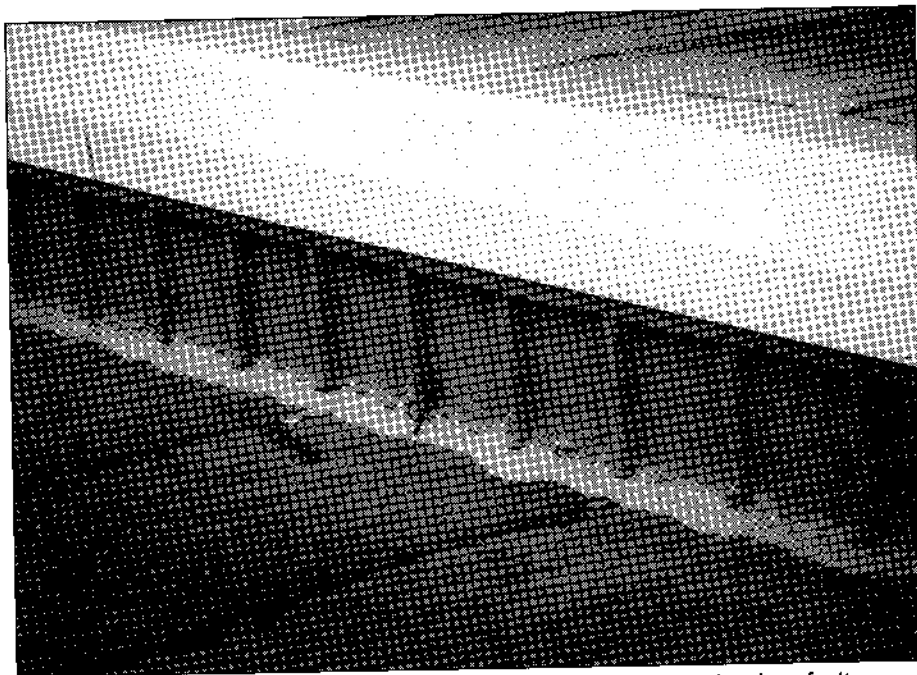
**Photo 10.** Roof 63: A low wall occurs between upper- and lower-level roofs. It appeared that the low roof/wall intersection was poorly detailed in the original construction. When the roof was reroofed, the existing awkward condition was not changed. Unless this detail is periodically repaired, premature leakage is likely. This five-year-old roof is located in New York.

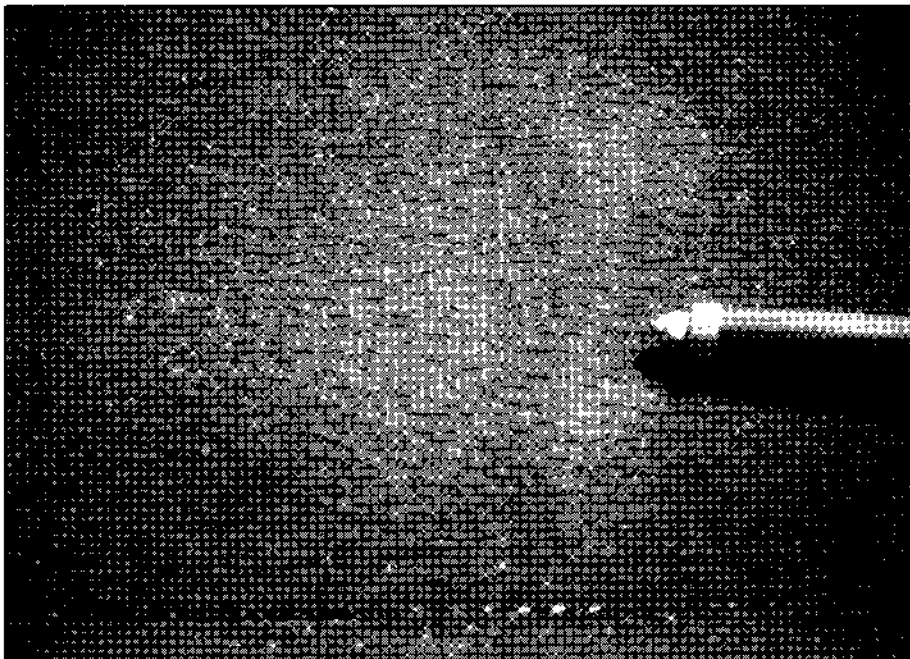
**Photo 11.** Roof 7A: Random membrane surface cracking of an APP modified bitumen membrane is shown. (A lumber keel shows the scale.) This six-year-old roof is located in Chicago.

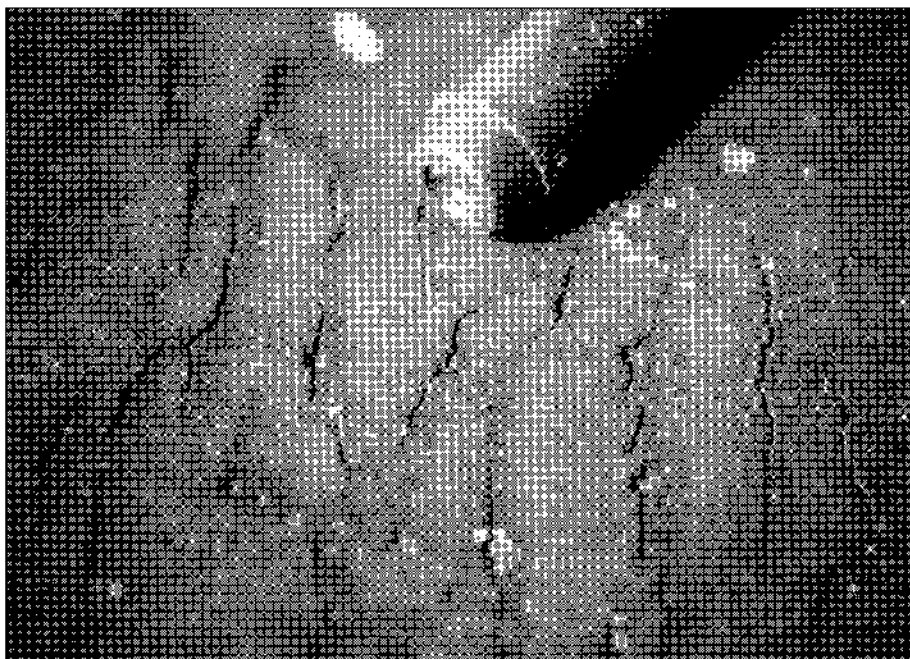
**Photo 12.** Roof 66: Random membrane surface cracking of an APP modified bitumen membrane is pictured. Several of the cracks extend from small craters (this same phenomenon was observed by Carlson in Reference 8). This nine-year-old roof is located in New York.

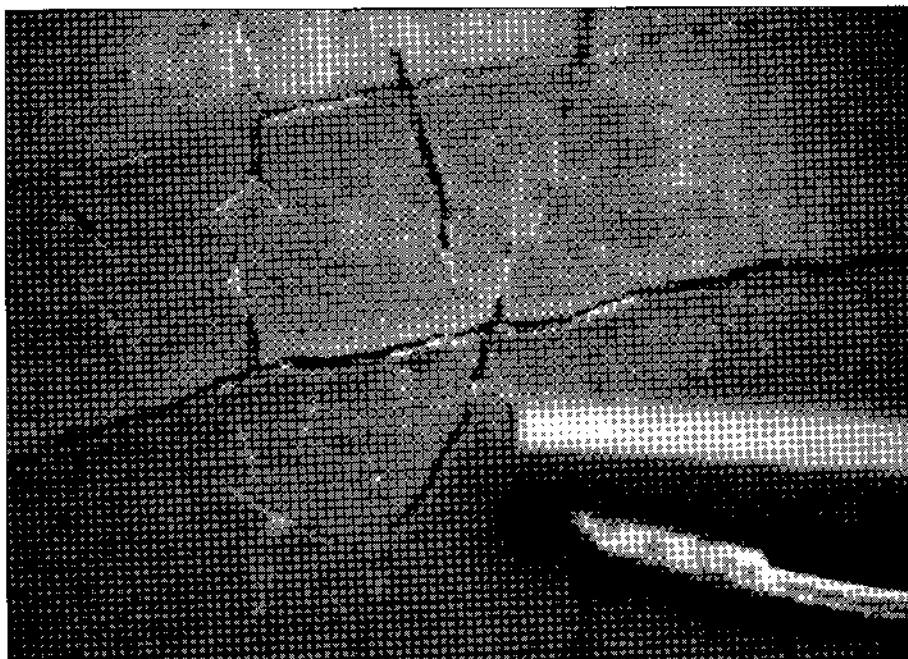
**Photo 13.** Roof 67: Deep random membrane surface cracking of an APP modified bitumen membrane is shown. On this roof, the cracking was more severe in ponded areas. This photo was taken near the edge of a large pond—depending upon the water level, this portion of the membrane could be submerged or dry. This eight-year-old roof is located in New York.

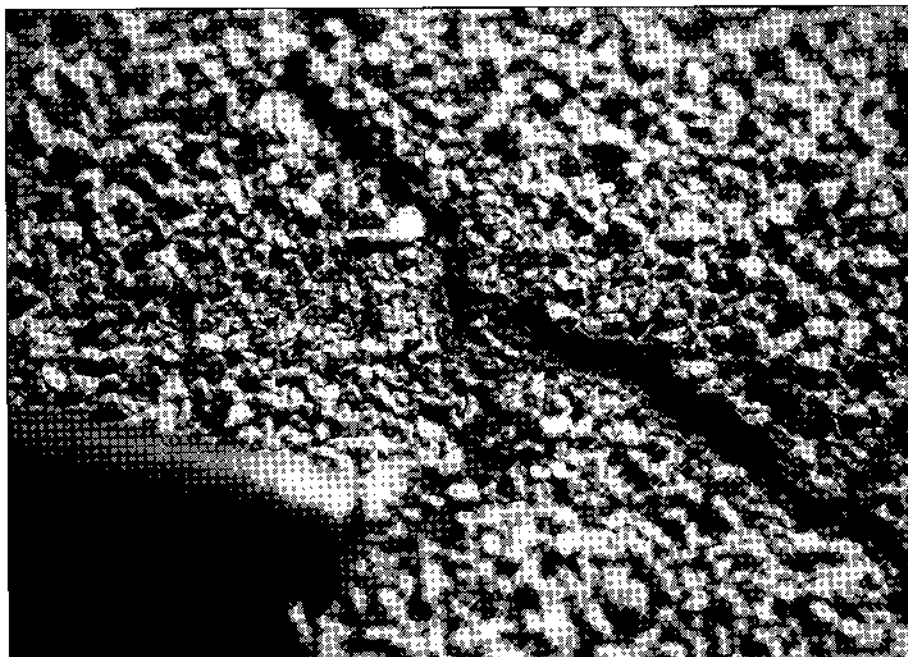
**Photo 14.** Roof 31: Random membrane surface cracking of an SBS modified bitumen membrane is illustrated. This four-year-old roof is located in Phoenix.

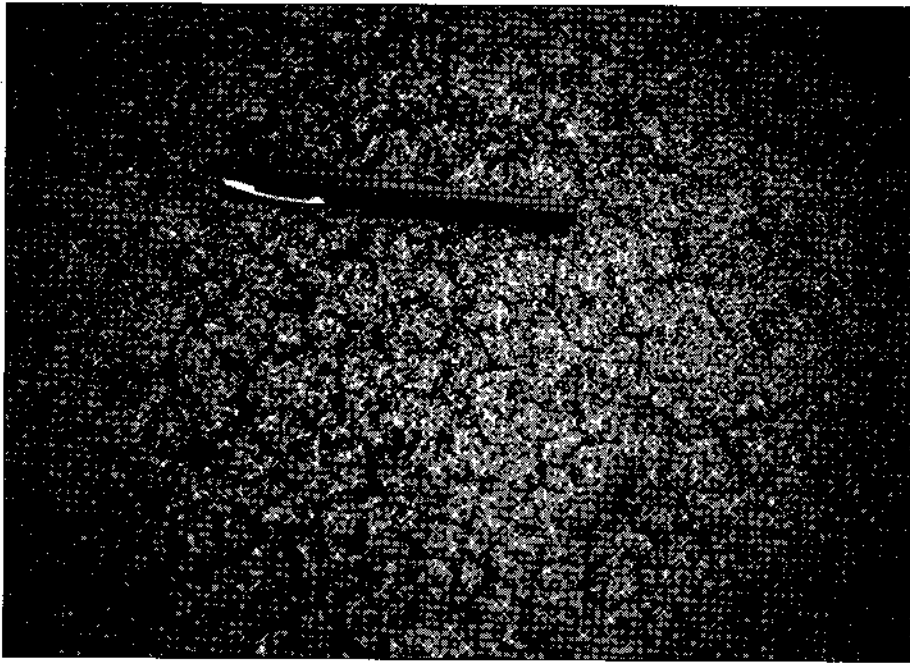
**Photo 15.** Roof 58: Random membrane surface cracking of an SBS modified bitumen membrane is shown. A substantial number of granules had been lost from this roof. The roof had a slope of approximately 3:12 (25 percent). Cracking was more severe on the western exposure, compared to the eastern exposure. At Roof 57A, which was a similar building nearby, and of the same age and membrane manufacturer, similar granule loss and cracking was observed. On that roof, the cracking was more severe on the southern, rather than the northern exposure. These ten-year-old roofs are located in New Orleans.

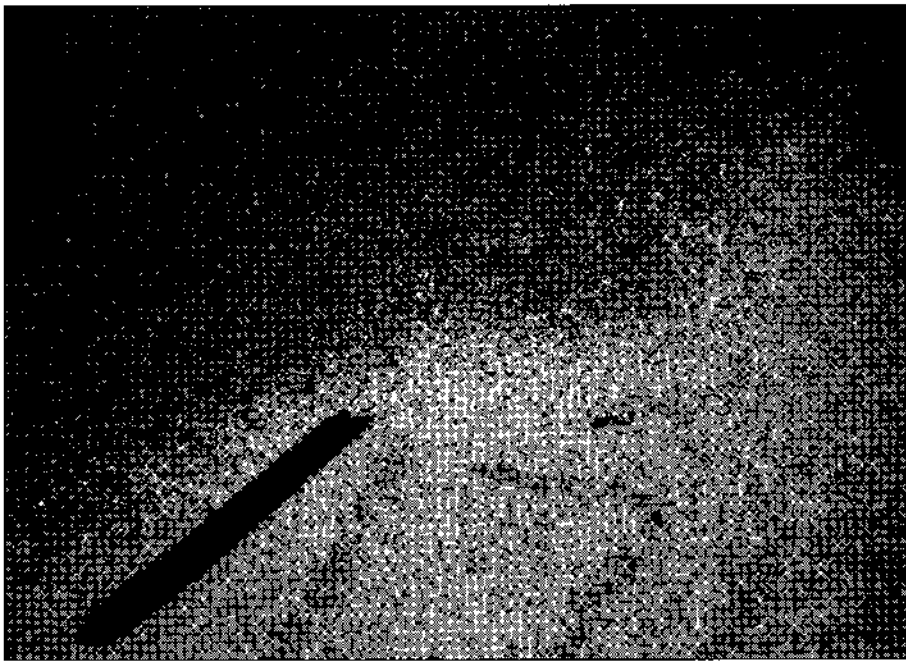
**Photo 17.** Roof 17B: Granule loss and random membrane surface cracking of an SBS modified bitumen membrane. This condition was limited to ponded areas (the darker, upper area of the photo is under water). This five-year-old roof is located in Kansas City.

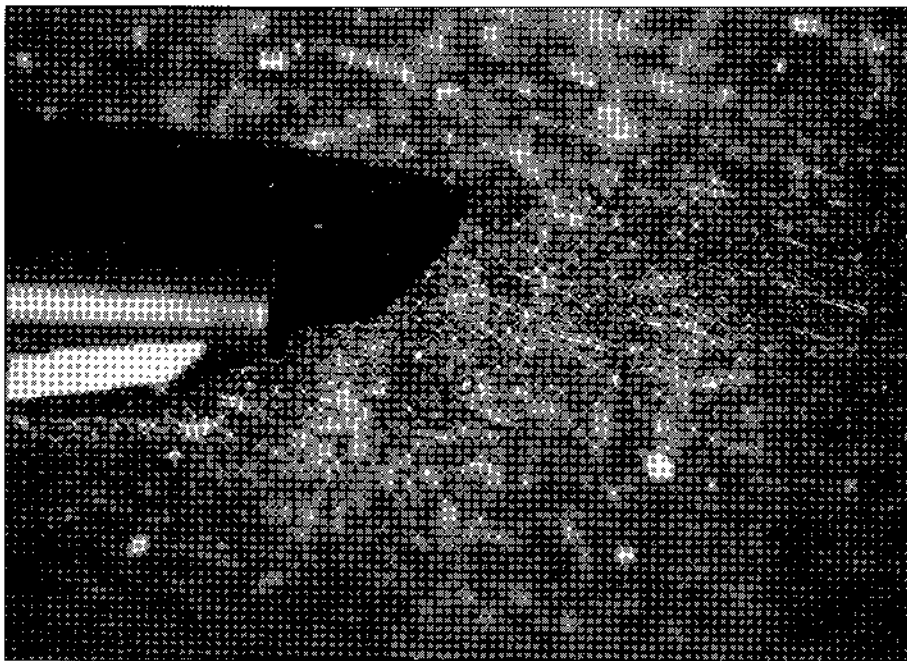
**Photo 18.** Roof 52: This APP modified bitumen membrane, with protective reinforcement near the top of the sheet, shows very little weathering effects. A few grains of sand and dirt are on the membrane, and some reinforcement fibers can be seen on the surface. This 13-year-old roof is located in New Orleans.

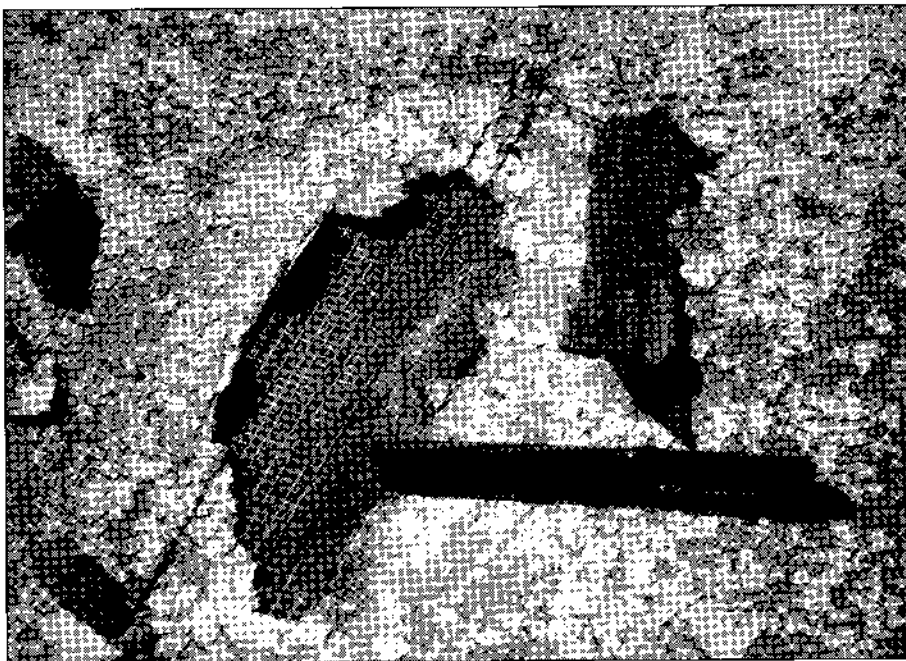
**Photo 19.** Roof 49: Delamination of portions of an APP modified bitumen sheet is pictured. The separation occurred between the glass fiber reinforcement near the middle of the sheet and the bitumen matrix above it (an additional layer of glass fiber reinforcement also occurs near the top of the sheet). Prior to cutting away the separated area for observation, the top portion of the sheet had ruptured, which thereby permitted water to enter the void area. The membrane had an aluminum-pigmented cutback coating applied over an emulsion coating. In this area, much of the aluminum coating had weathered away. This eight-year-old roof is located in New Orleans.

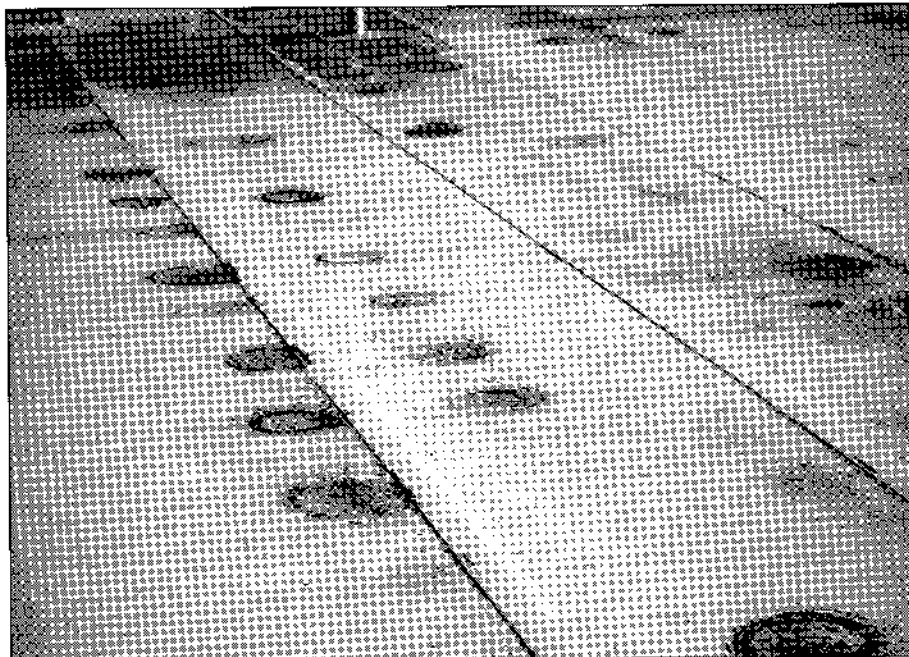
**Photo 20.** At another area of Roof 49, delaminations occurred above screw-and-plate fasteners that were used to attach the insulation, as depicted by the large diameter dark circles. A test cut at one of these areas revealed the separation occurred in the same location as described in Photo 19. Although in this case, the portion of the sheet above the separation was not deteriorated, as it was in Photo 19.

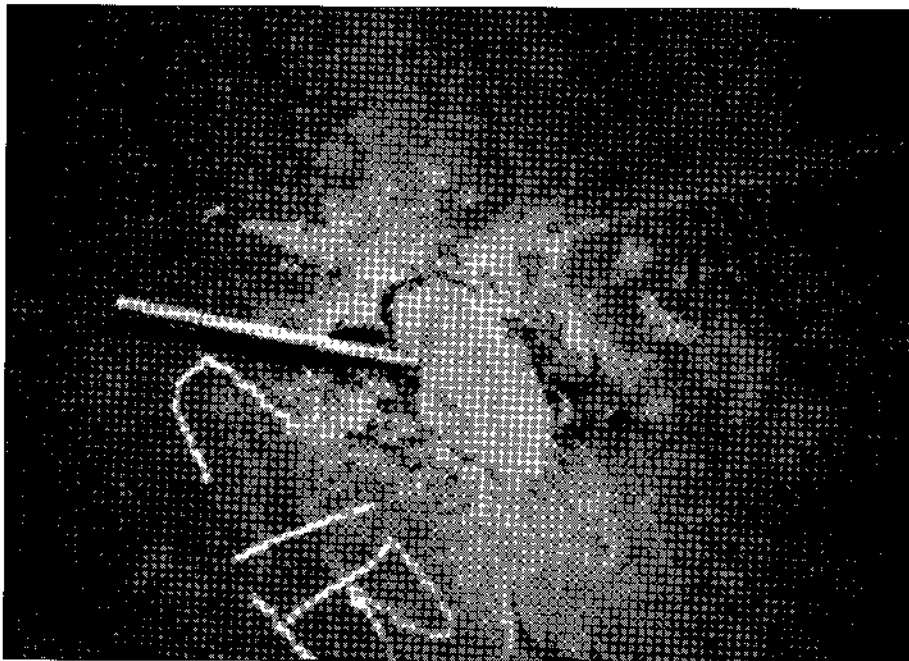
**Photo 21.** Roof 21B: Separation and rupture of the glass fiber reinforcement near the top of the APP modified bitumen sheet is shown. This nine-year-old roof is located in Kansas City.

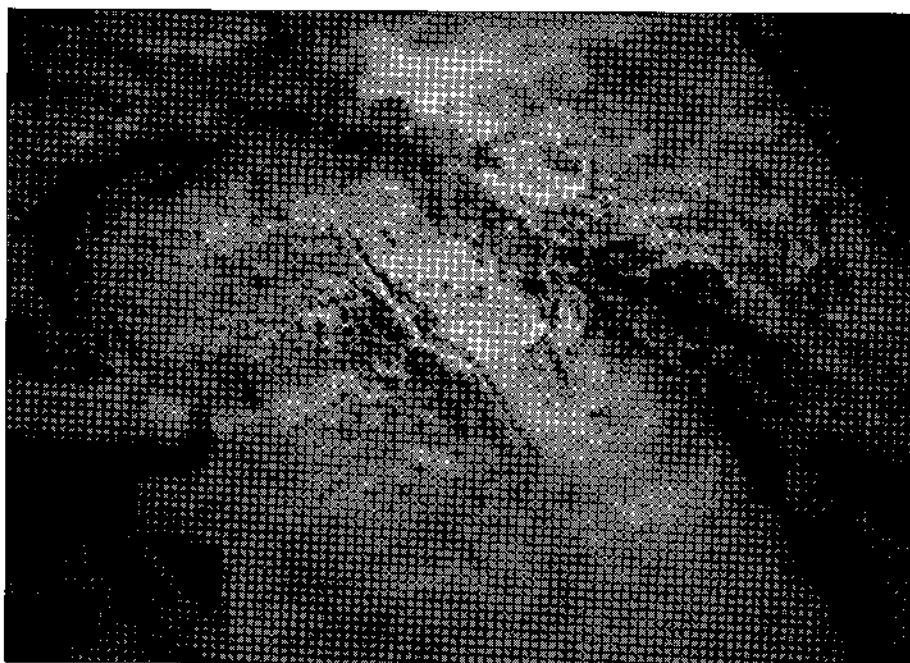
**Photo 22.** Close-up of Photo 21: A deep crack occurred in the exposed surface of the sheet. (The crack was full of water when the photo was taken.)

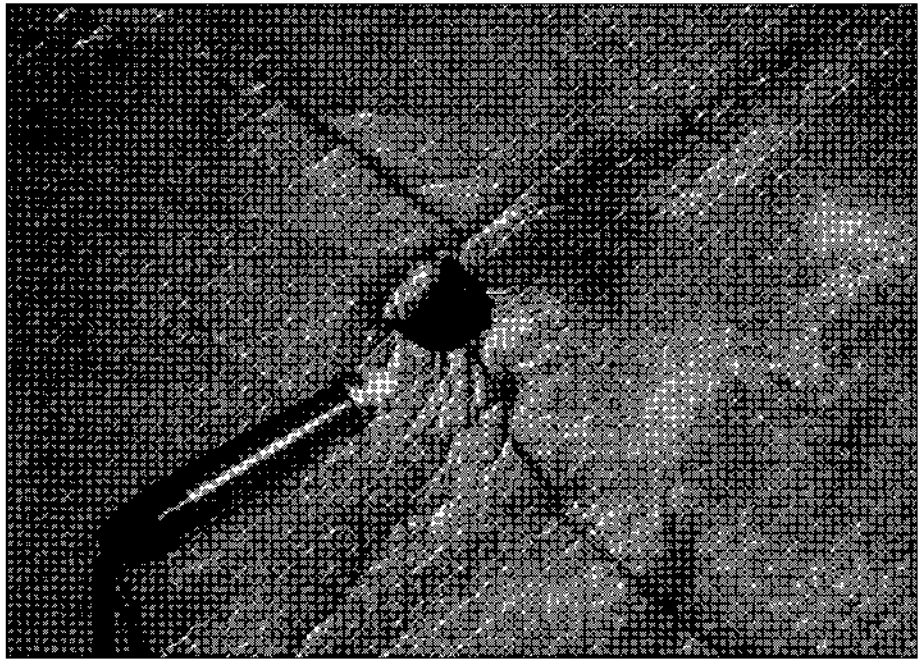
**Photo 23.** Roof 7D: Metal foil delamination (and tear) on an APP modified bitumen membrane is pictured. The age of this roof is unknown. It is located in Chicago.

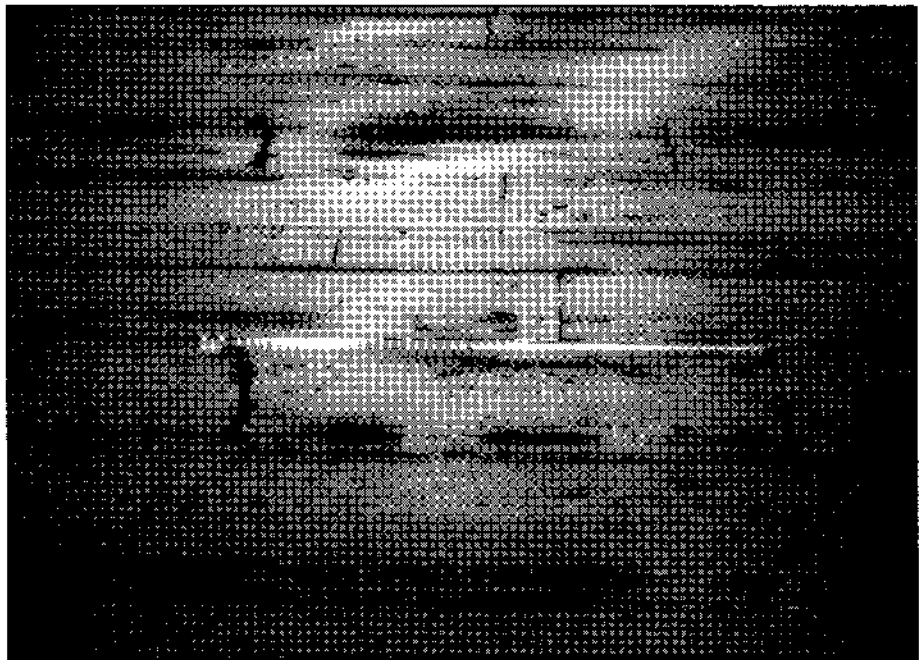
**Photo 24.** Roof 44B: Metal foil has torn at several locations across this sheet and has delaminated (peeled) from the sheet. This five-year-old roof is located in Seattle.

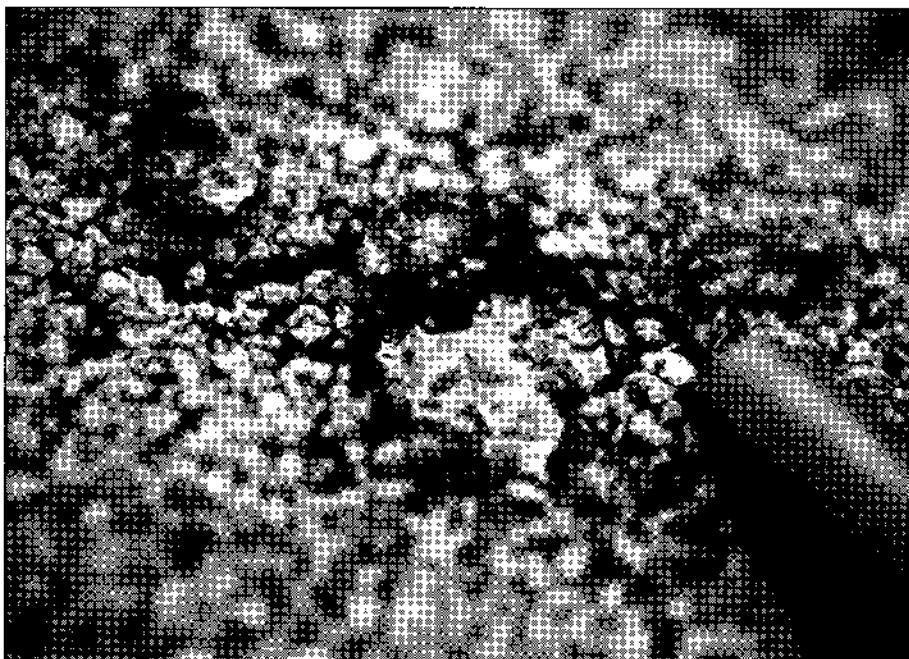
**Photo 26.** Roof 56: Close-up of a ruptured blister on a granular-surfaced SBS modified bitumen membrane (the blister was ruptured by the investigator) is shown. The blister occurred in the bitumen matrix, above the reinforcement. In this case, the void was dry. Note the lack of granules in this area. The roof had a slope of approximately 3:12 (25 percent). This ten-year-old roof is located in New Orleans.

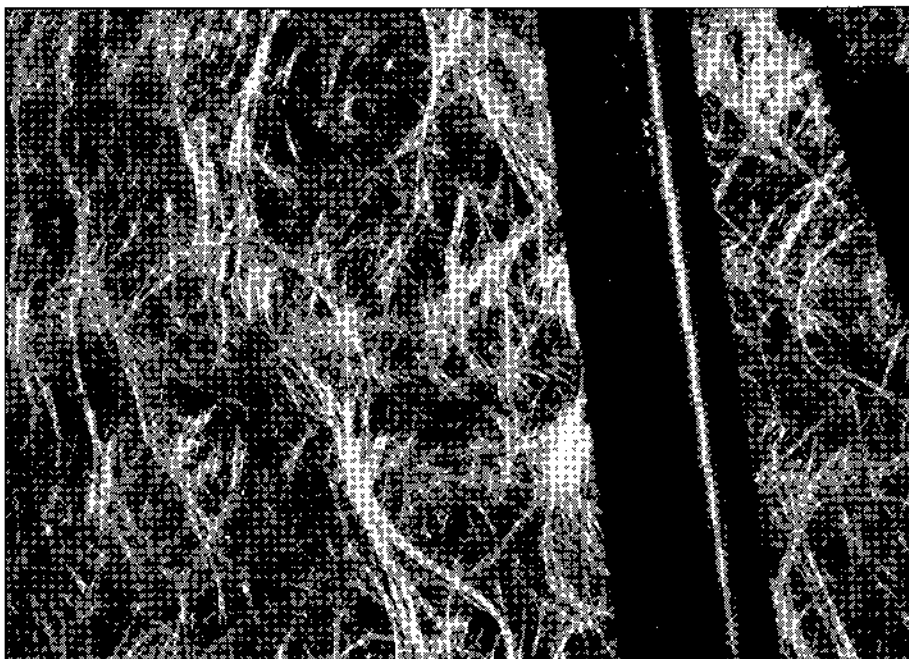
**Photo 27.** Roof 13B: Close-up of an advanced stage of fiberglass bloom on an APP modified bitumen membrane is illustrated. The majority of this roof had a low slope, although this photo was taken at a steep-sloped area. This nine-year-old roof is located in Kansas City.

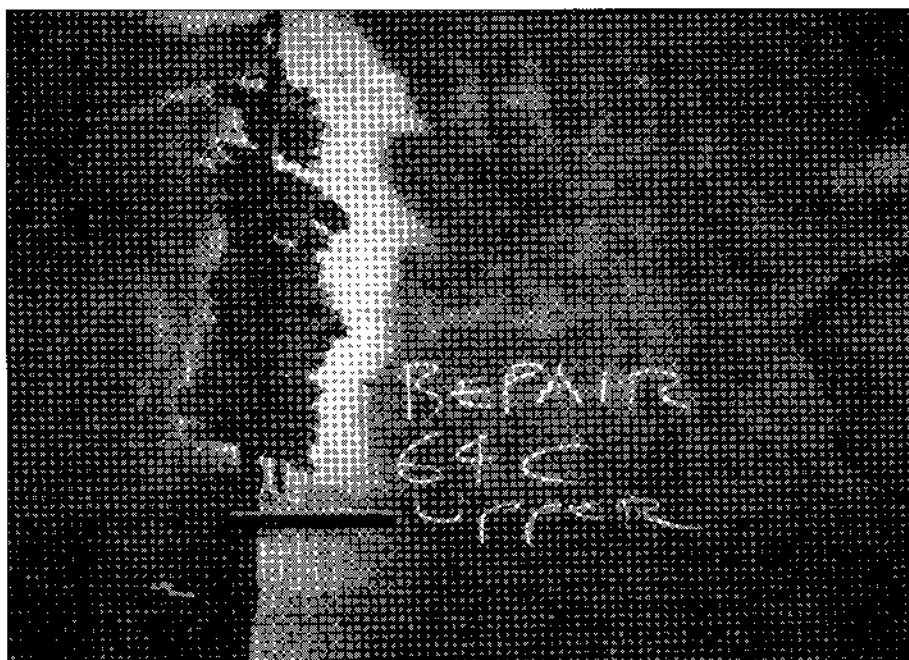
**Photo 28.** Roof 64C: Finger blisters occurred near the upper right hand area of this photo of an APP modified bitumen membrane. This photo also shows a lap that was repaired some time after the roof was installed. The addition of a stripping ply over the repaired area would offer a more conservative repair. This three-year-old roof is located in New York.

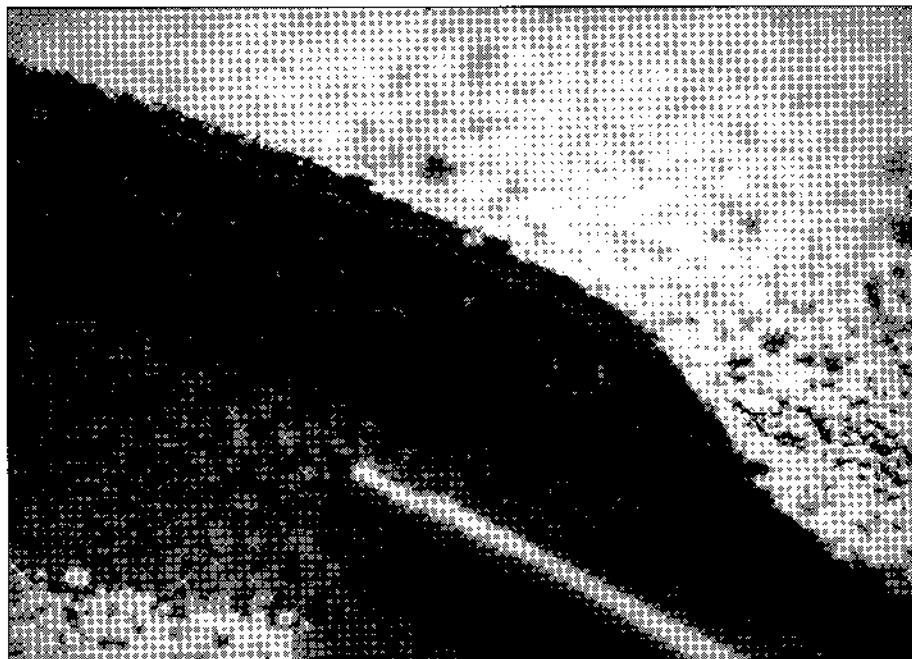
**Photo 29.** Roof 16: Close-up of a loose endlap on an APP modified bitumen membrane is pictured. This roof experienced a substantial amount of granule loss and lap problems, which may also have been associated with the granules. Note that several granules are embedded on the underside of the top sheet. This two-year-old roof is located in Kansas City.

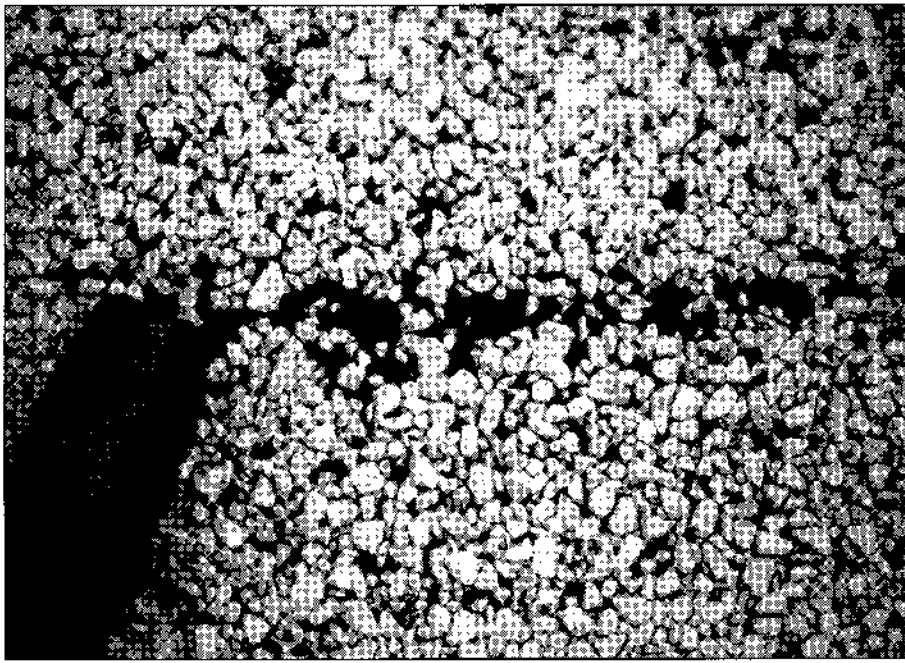
**Photo 30.** Roof 65A: Close-up of granule loss along the ridge of a blister on an SBS modified bitumen membrane is shown. Note that even away from the ridge line, the granule coverage is not continuous. This five-year-old roof is located in New York.

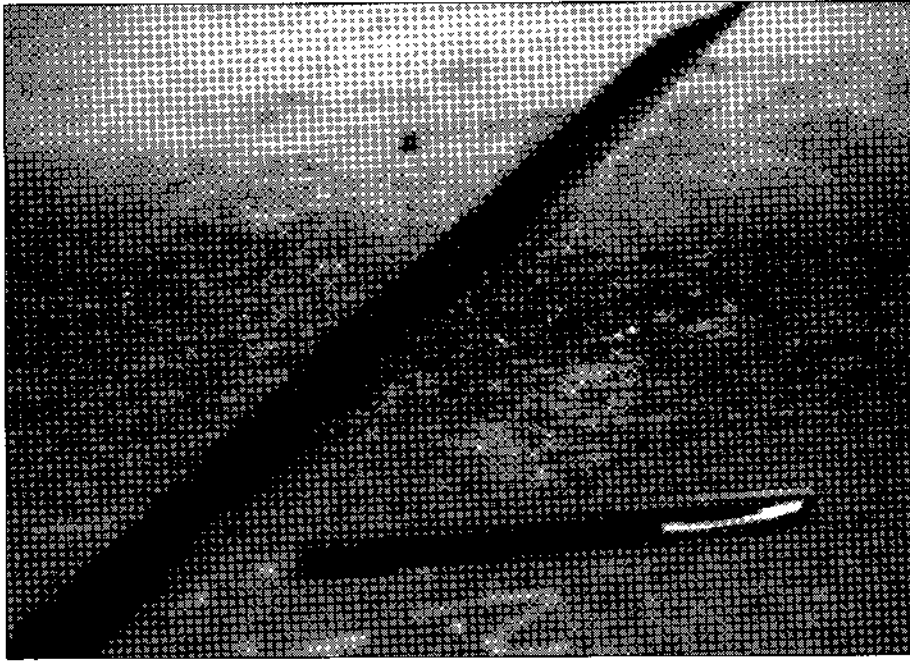
**Photo 32.** Roof 2: Lap separation (lifting and peeling) of a self-adhering polymeric-surfaced SEPS membrane roof is shown. This separation occurred in a ponded area. The age of this roof, which is located in Chicago, is unknown.

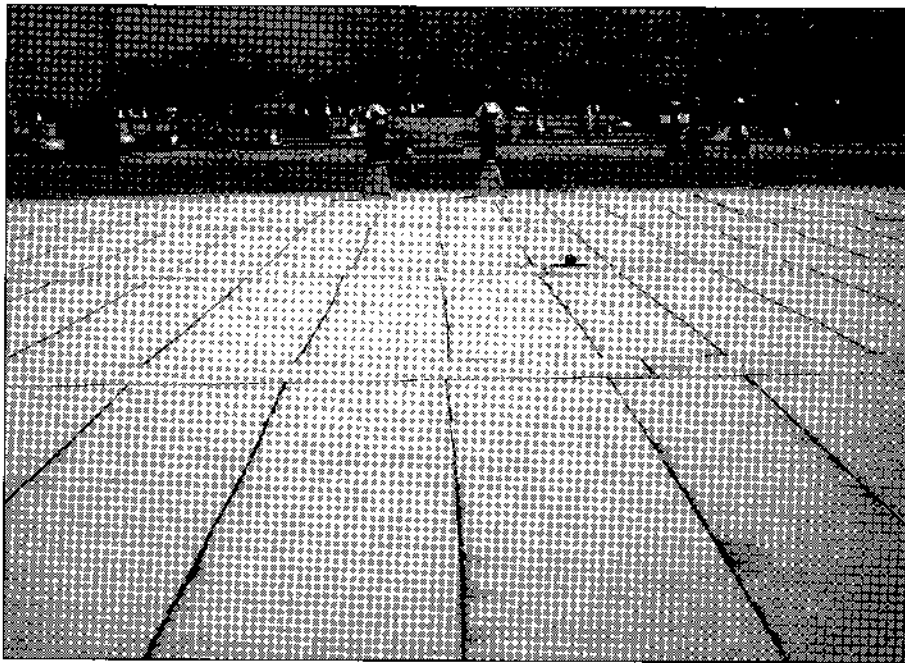
**Photo 33.** Roof 6: Several of the APP modified bitumen sheets on this roof exhibited hooking. This two-year-old roof is located in Chicago.

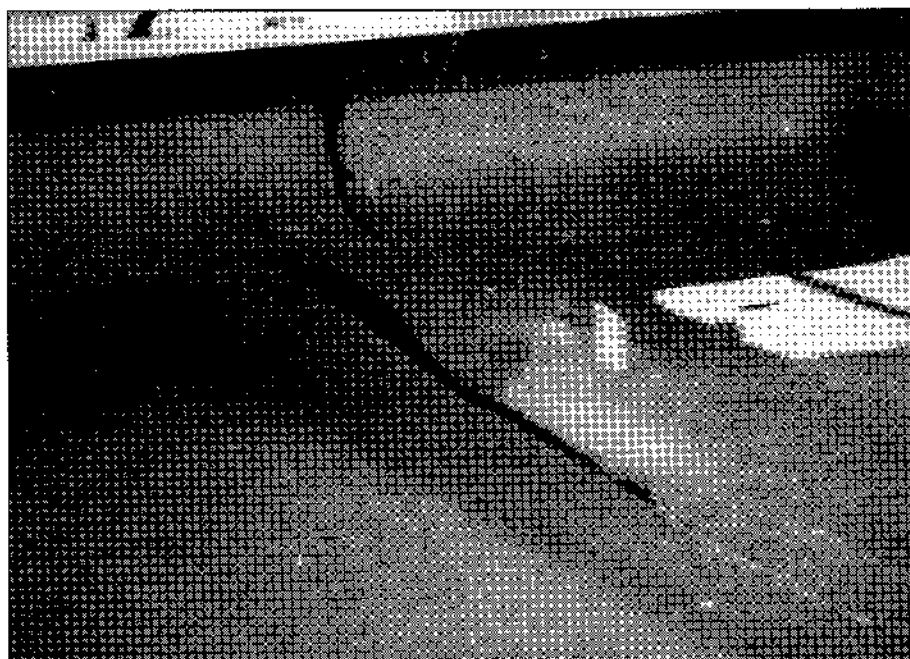
**Photo 35.** Roof 17B: The cap sheet lap has nearly pulled apart near the top of this large blister. This five-year-old SBS modified bitumen membrane is located in Kansas City. Although in many instances blister repair is not needed, this illustrates a condition where repair is important.

Blisters often do not present problems. However, if a blister has a separated lap (or one that may soon separate), it should be repaired (Photos 35 and 36).

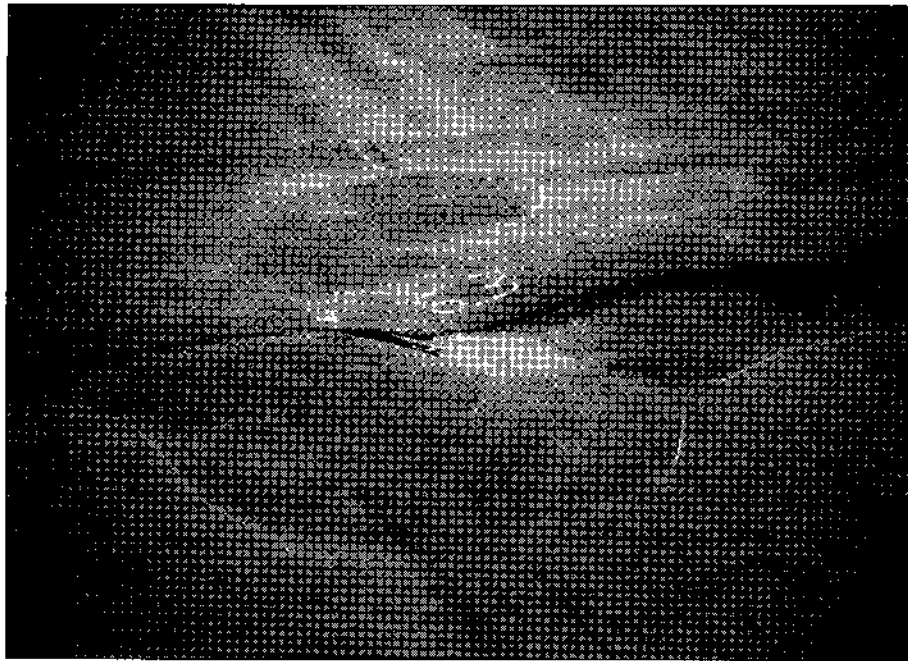
**Photo 36.** Roof 63: An ink pen is extended 2¼ in. (55 mm) into an open sidelap. The blister directs water into this open lap. This five-year-old SBS modified bitumen membrane is located in New York.

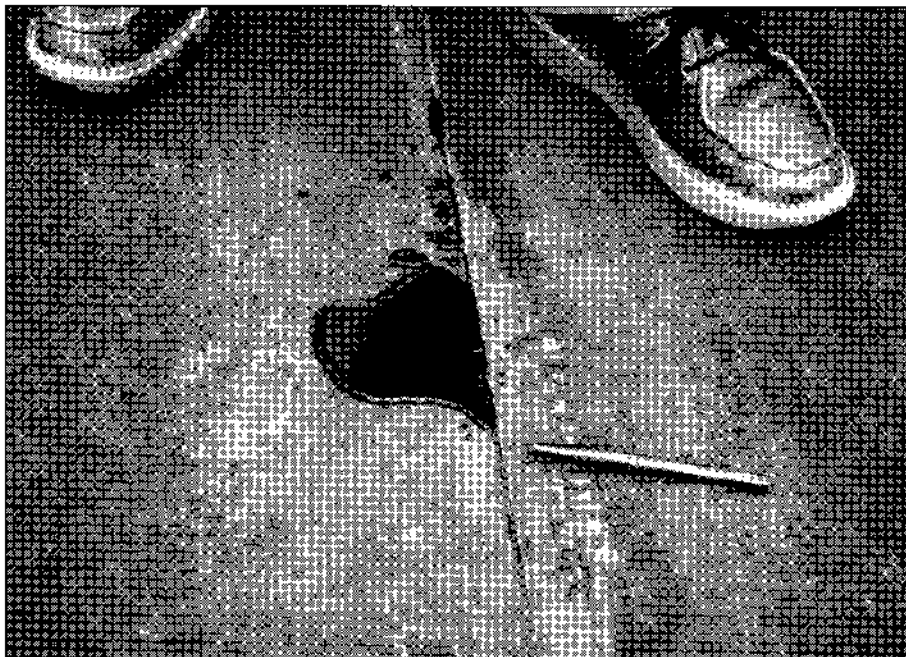
**Photo 37.** Roof 54B: Water flowed out of this lap when it was stepped on. This six-year-old APP modified bitumen membrane is located in New Orleans.

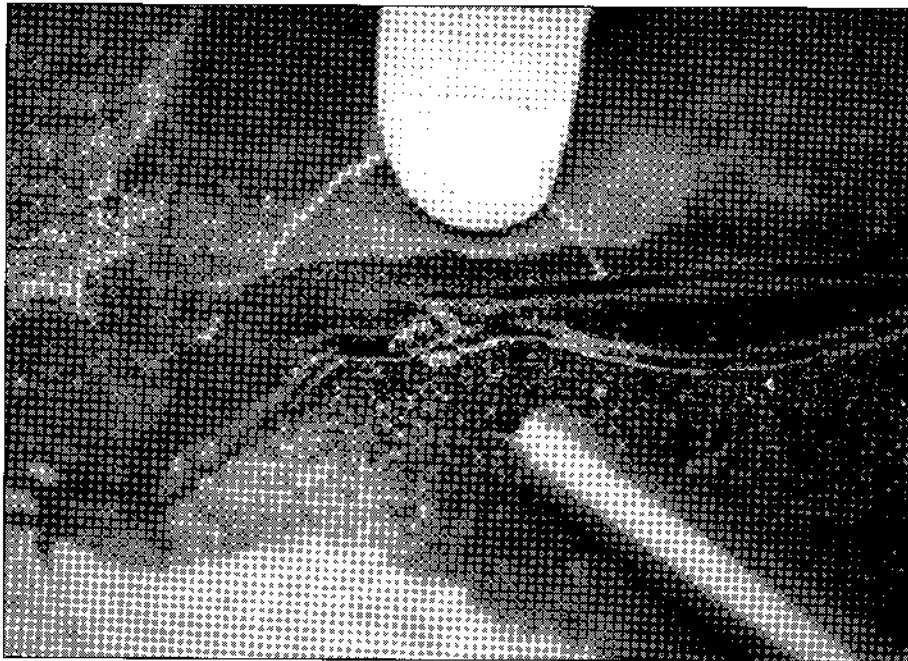
**Photo 38.** Roof 64C: This roof had experienced several lap problems (see Photo 28). Along the lap area, a thumb was pressed on the lap in an attempt to see if it contained water. Some water was laying on part of the membrane where this photo was taken. When the lap was pushed, air bubbles were formed (the ink pen points toward the bubbles). Even though there was bitumen bleed-out from the lap, the lap is not continuously sealed. This three-year-old APP modified bitumen membrane is located in New York.
