# APP and SBS Modified Bitumen Membrane Roofs:

A Survey  
of Field  
Performance

MIDWEST ROOFING  
CONTRACTORS  
ASSOCIATION, INC.

NATIONAL  
ROOFING  
CONTRACTORS  
ASSOCIATION

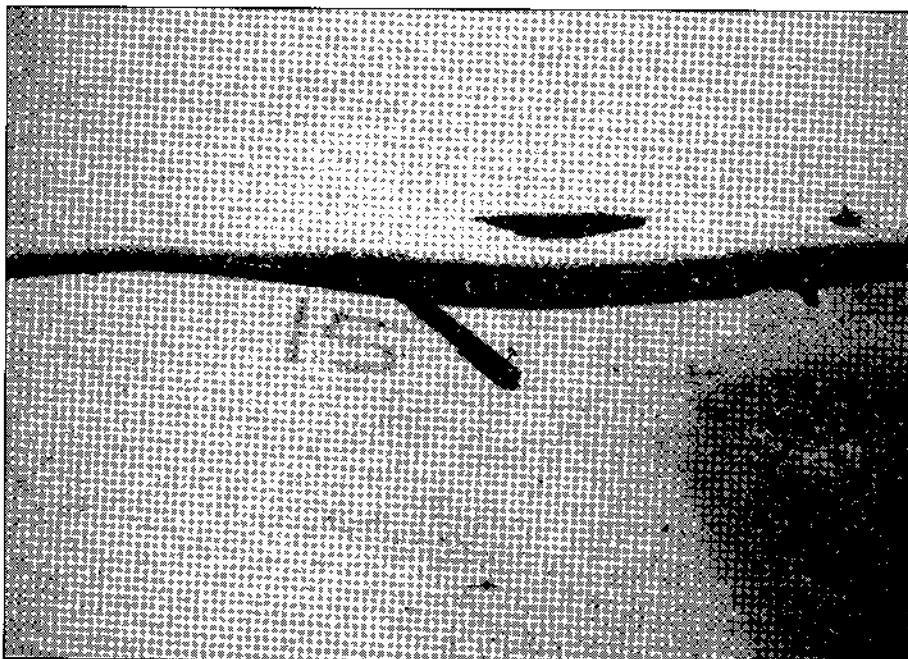
**Photo 39.** Roof 15A: This lap problem is located near a roof drain, which is out of the picture to the right. The roof insulation was tapered to slope to the drain. The open lap is near the outer edge of the taper. This two-year-old SBS modified bitumen membrane is located in Kansas City.

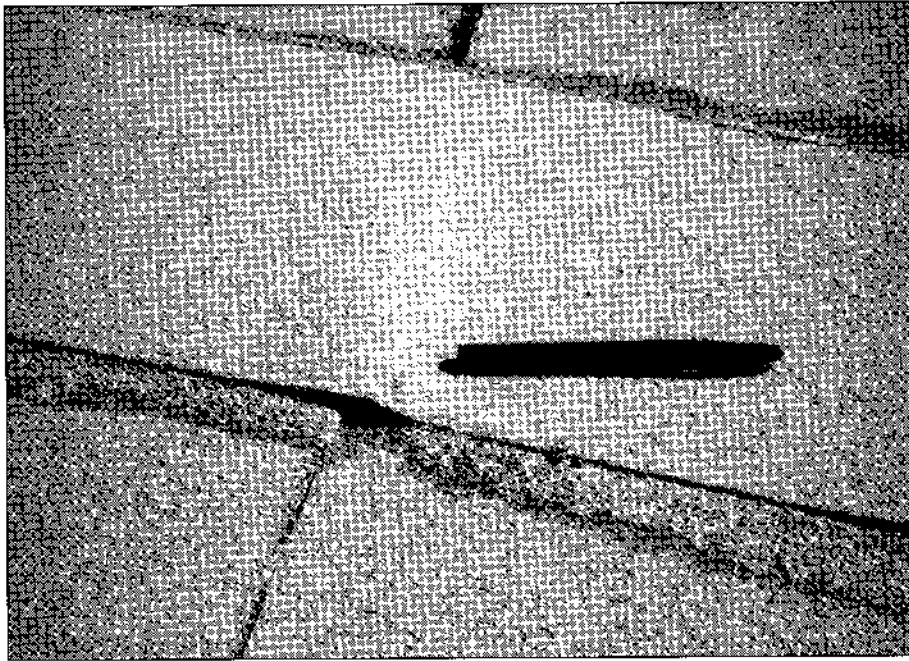
**Photo 40.** Roof 24B: This lap problem occurred at the T-joints of a header sheet. This three-year-old SBS modified bitumen membrane is located in Phoenix.

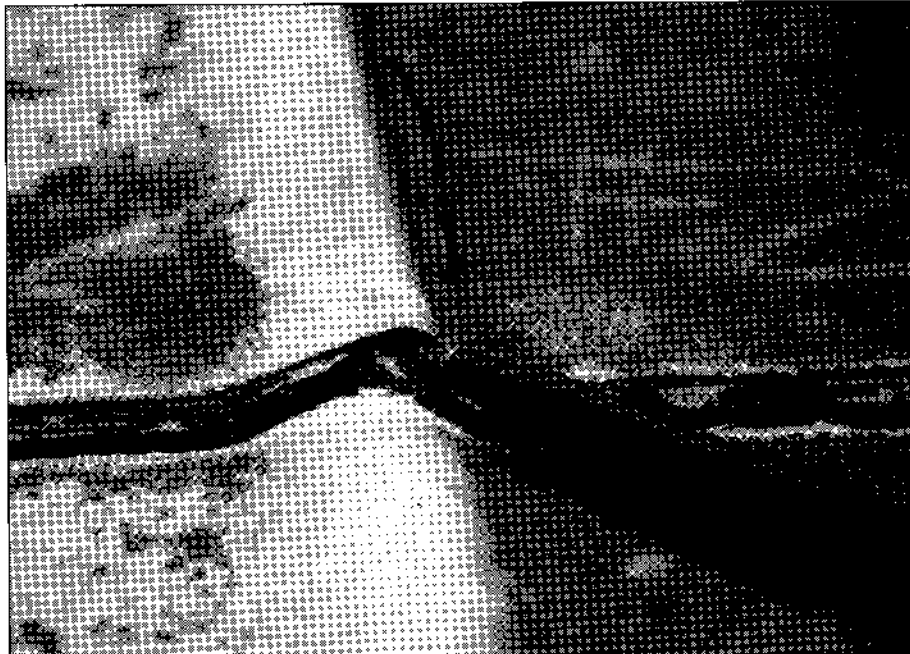
**Photo 41.** Roof 2: An endlap opening at a ridge is shown. The age of this SEPS modified bitumen membrane, which is located in Chicago, is unknown.

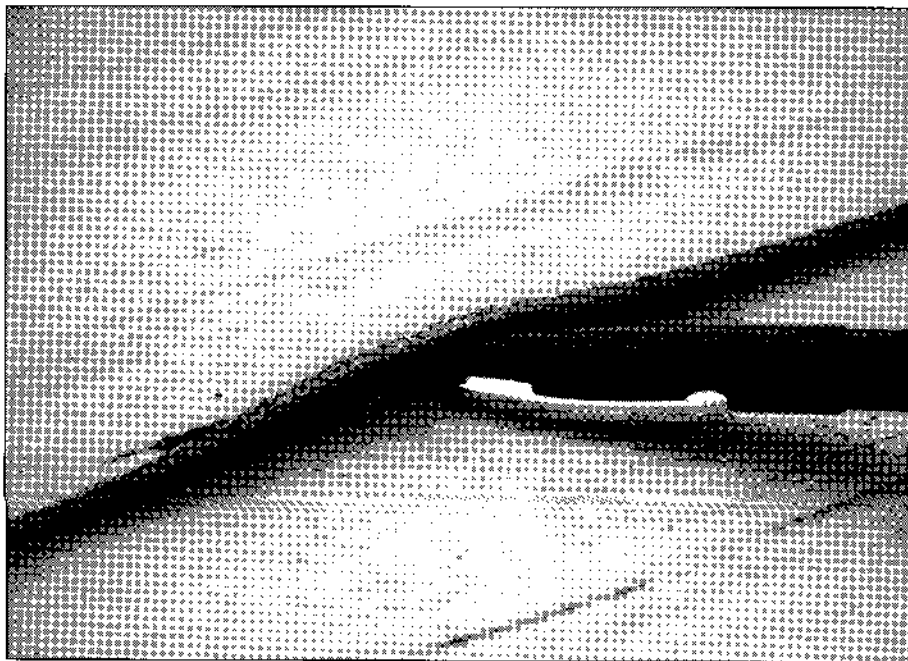
**Photo 42.** Roof 3B: The lap of the APP modified bitumen membrane was not sufficiently heated at the time of application. This two-year-old roof is located in Chicago.

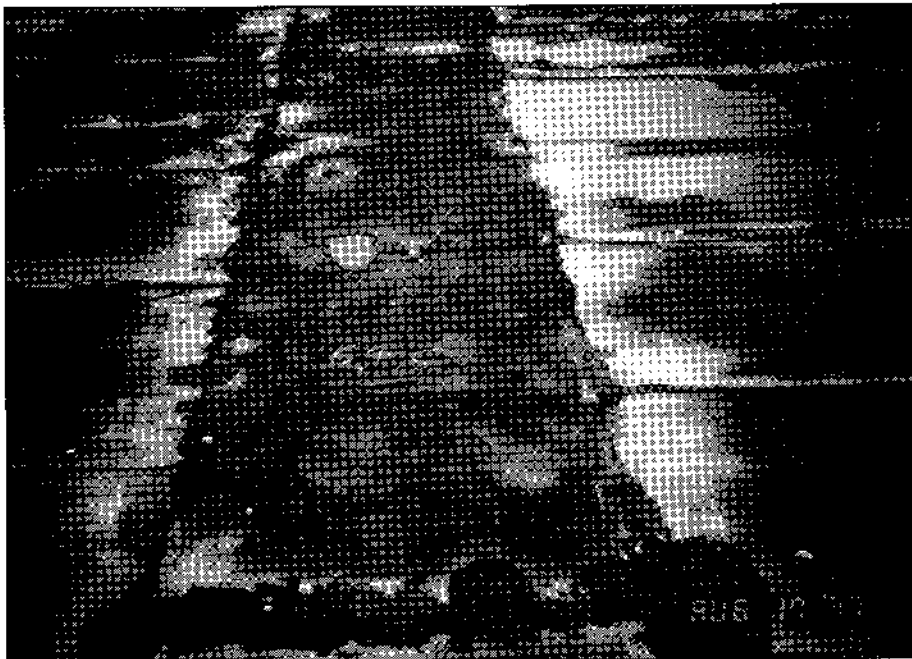
**Photo 43.** Roof 64C: Footprint depressions were made in the header sheet. These are caused by walking over the sheet while it is hot.

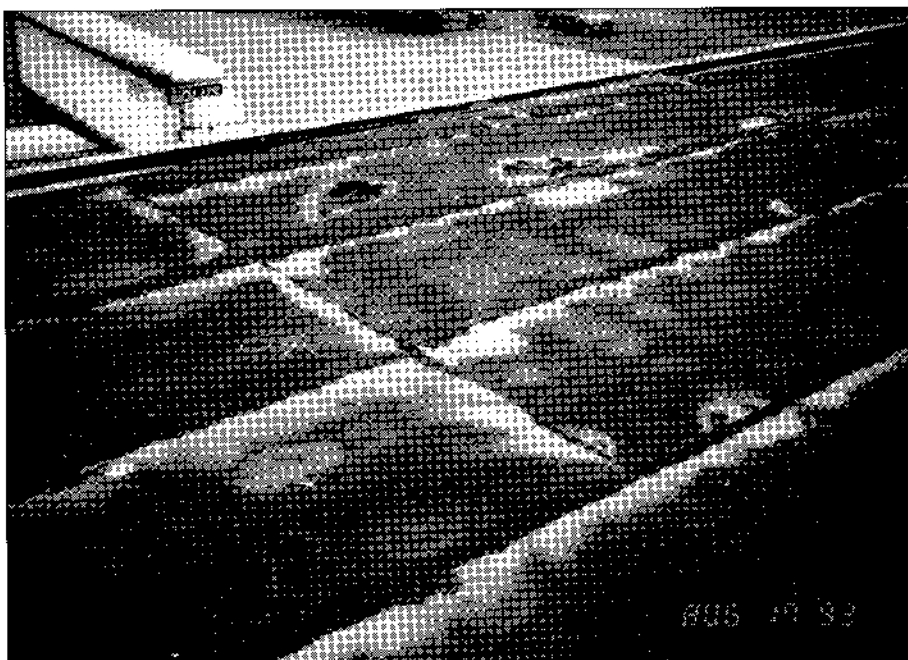
**Photo 44.** Roof 64C: These three endlaps were not staggered, but there were no apparent problems. This three-year-old APP modified bitumen membrane is located in New York.

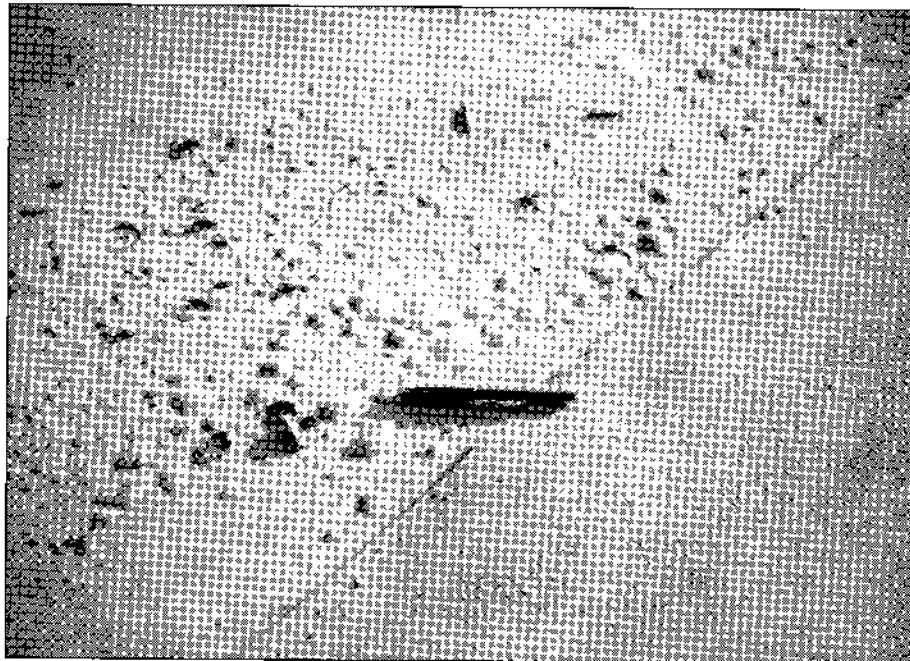
**Photo 45.** Roof 51: Blistering of an emulsion coating on a ten-year-old APP modified bitumen membrane in New Orleans is pictured. The broken blisters were ruptured by the investigator. The cause of the blisters was not determined.

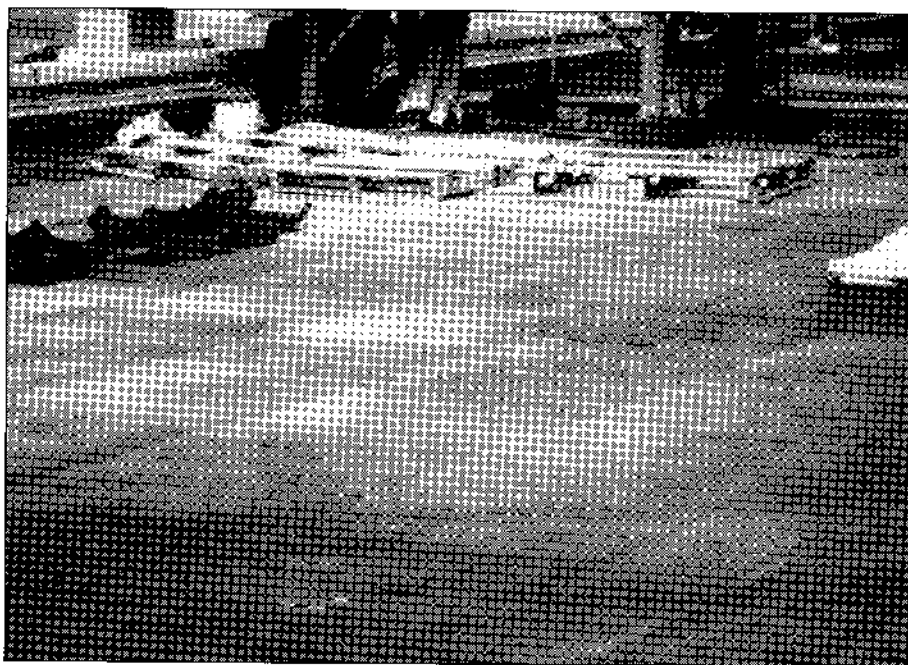
**Photo 46.** Roof 4A: Wood pallets and heavy pieces of steel and other material are laying on the membrane of this manufacturing facility. The membrane has been punctured in the foreground, near the ink pen. This nine-year-old APP modified bitumen membrane is located in Chicago.

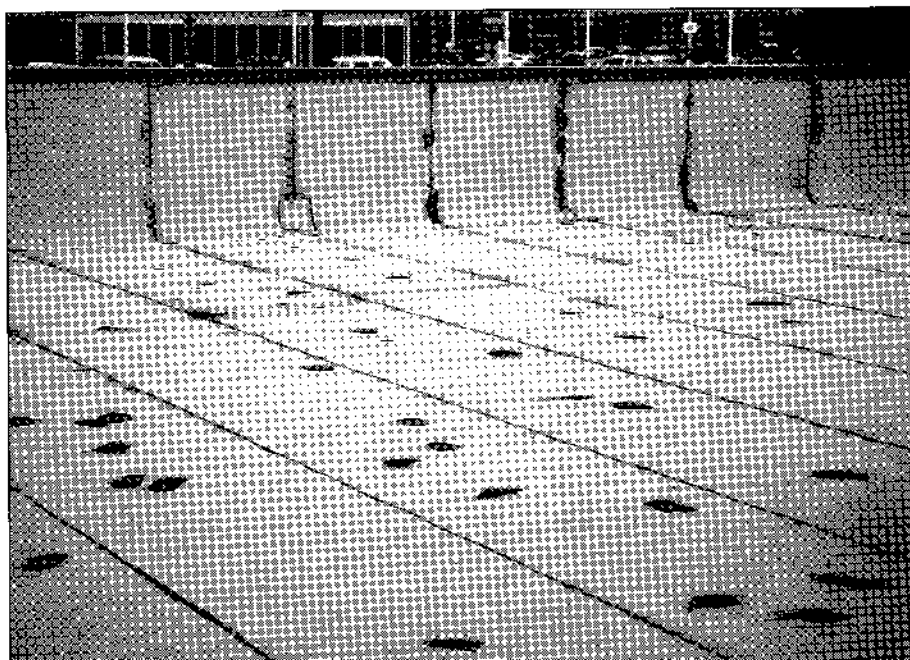
**Photo 47.** Roof 16: This granule-surfaced APP modified bitumen membrane (which was composed of a cap sheet and a base sheet over phenolic insulation) was punctured by hail in a number of locations. The dark spots are where emergency repairs were made with asphalt roof cement. This two-year-old roof is located in Kansas City.

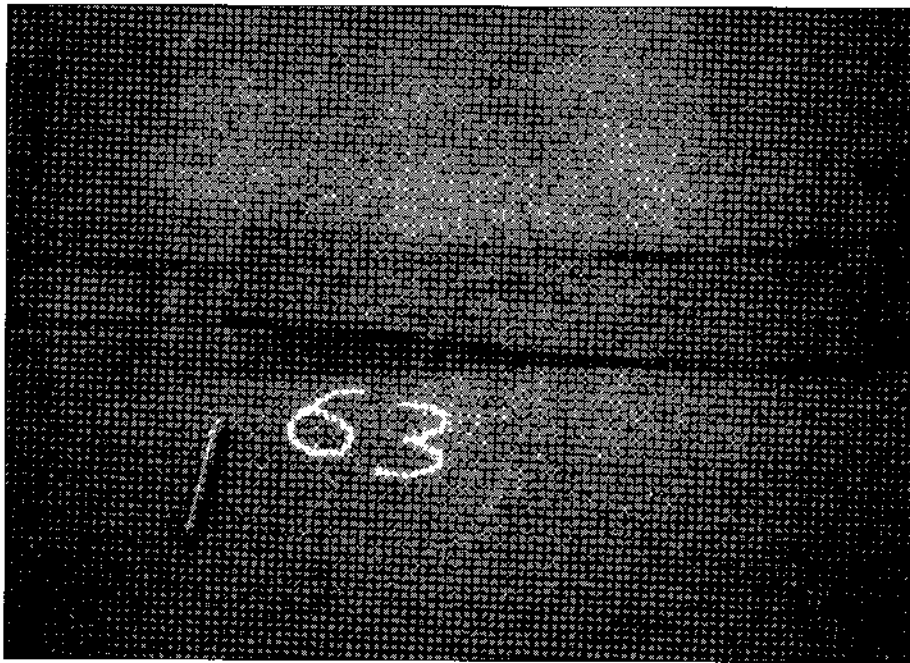
**Photo 48.** Roof 63: The factory splice was not cut out of this cap sheet before it was installed. Water infiltration through the cap sheet is possible. This five-year-old SBS modified bitumen membrane roof is located in New York.

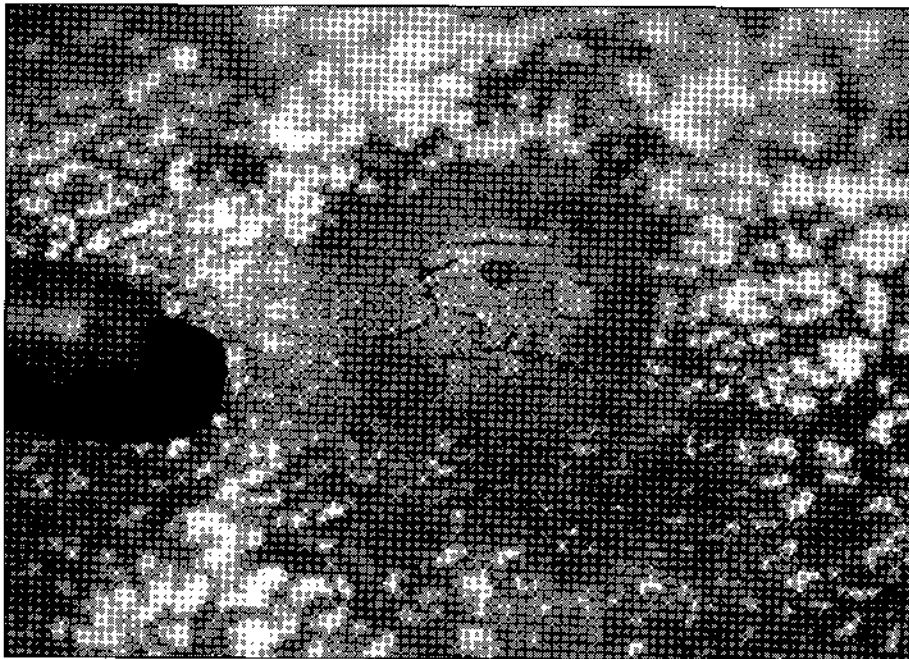
**Photo 49.** Roof 72: Fastener backout or pop-up caused the development of these deep membrane cracks. This six-year-old APP modified bitumen membrane roof is located in New York.

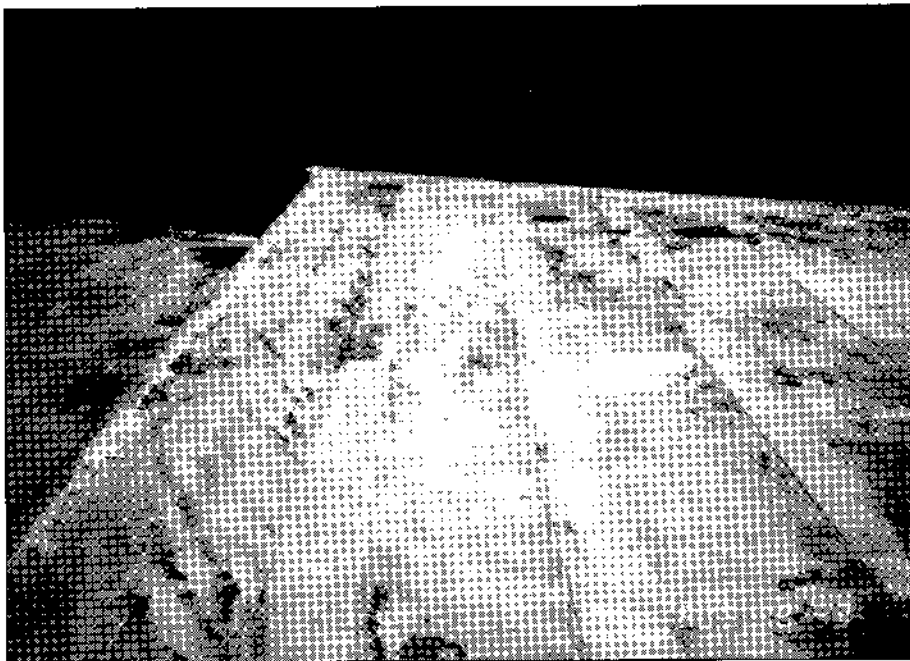
**Photo 50.** Roof 71: Diagonal walking is typically caused by lack of insulation attachment. This eight-year-old APP modified bitumen membrane is located in New York.

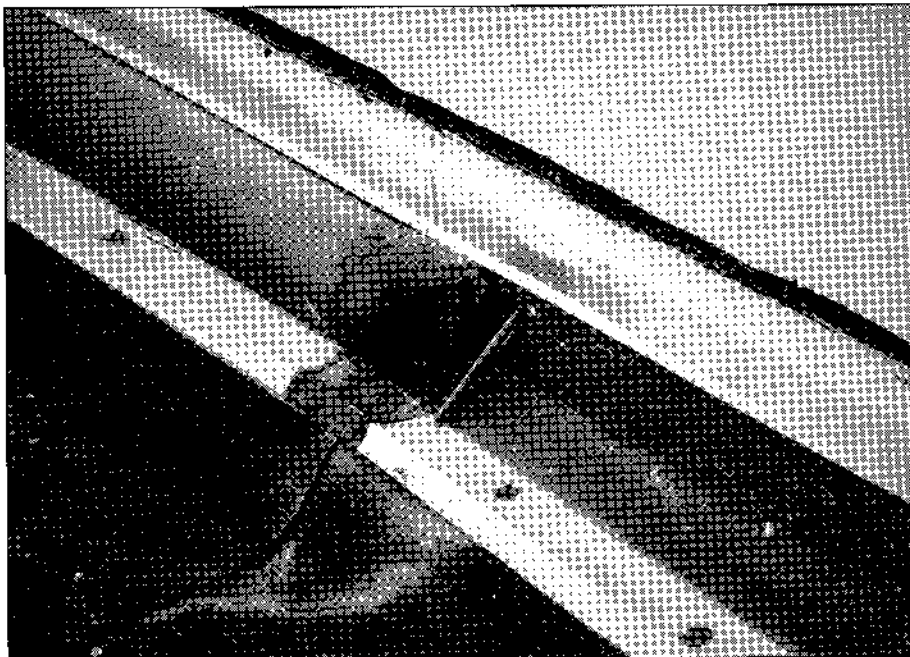
**Photo 51.** Roof 64B: The joint at the bellows of the expansion joint cover has failed. This appeared to be a material or workmanship failure. This six-year-old roof is located in New York.
