MRCA Roof Coatings Research

-- A Progress Report --

MRCA Coating Research Program Photo Log

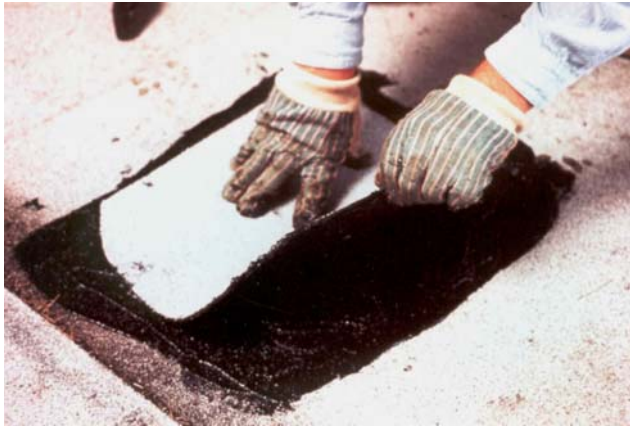
Roof maintenance generally involves administering spot repairs to patch or repair weather-weakened, deficient locations in a roof membrane (see Photo 1). After spot repairs have been made to smooth- and granule-surfaced roof membranes, roof maintenance can involve preparing the existing roof surface, then applying a surface coating or a combination of coatings to reduce the effects of direct weathering, thereby prolonging the life of the existing roof membrane (see Photo 2).

Photo 1: Shows installation of a spot repair at weather-weakened deficient location of roof membrane.

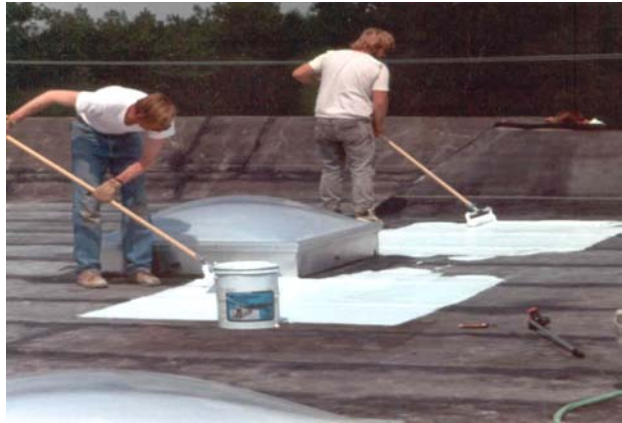
Photo 2: Application of surface coating to shield roof membrane from direct effects of weather and prolong life of roof membrane.

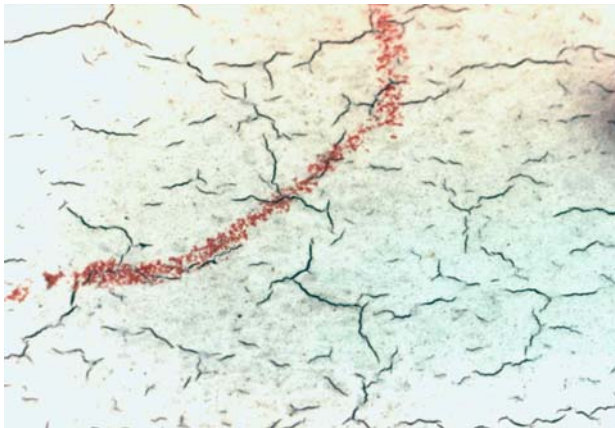
However, in some North American roofing markets, roofing contractors, designers and building owners have reportedly experienced frustration when using various coatings with specific roof membranes. For example, when several manufacturers of APP-polymer-modified asphalt roof membranes required the application of a liquid-applied coating as a condition of their roof warranties, but gave minimal guidance on when and how to coat the roofs. Various coatings degraded prematurely (e.g., yellowed, faded, asphalt bleed-through the coating, etc.). Some roof systems experienced difficulties with coatings that crazed, cracked, peeled, flaked off, or eroded and wore off prematurely (see Photos 3, 4 and 5 for examples).

Photo 3: Close up of initial cracking of surface coating.

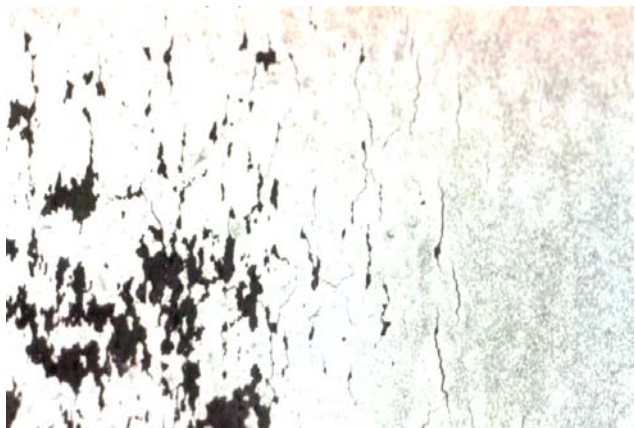
Photo 4: Shows initial cracking and peeling of surface coating.

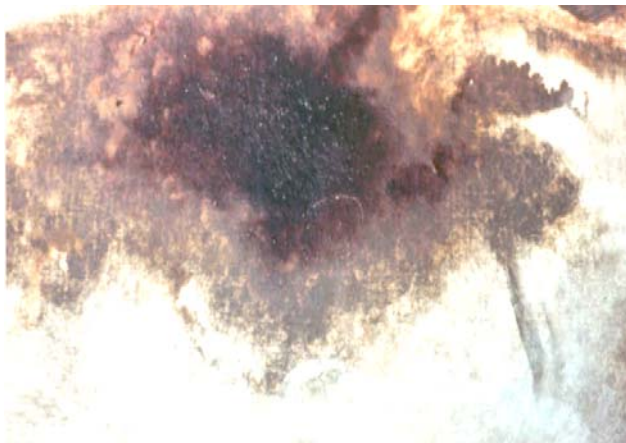
Photo 5: Shows accumulation of asphalt bleed-through on the surface of coating

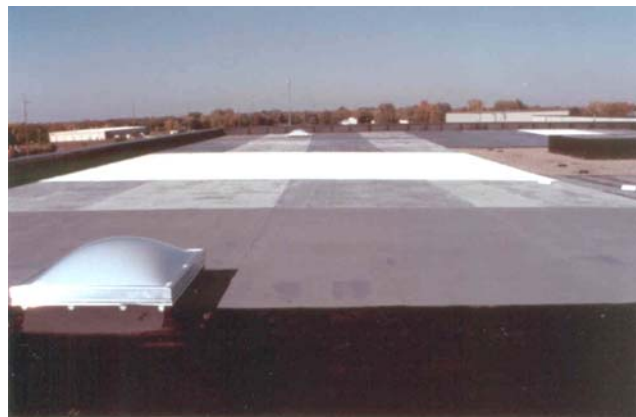
Photo 12: Depicts orientation of roof coatings applied to minimize the effects of differential thermal movement upon the coated roof membranes.

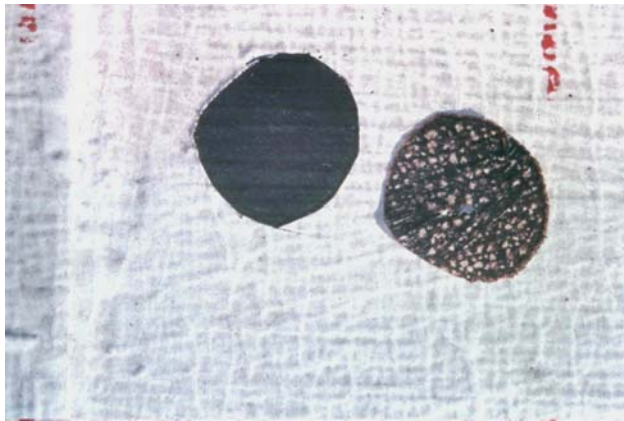
Photo 13: White acrylic coating applied to an asphalt-based membrane primed with asphalt emulsion revealed increased adhesion and peel strength, as evidenced by well bonded emulsion on the bottom side of acrylic coating.

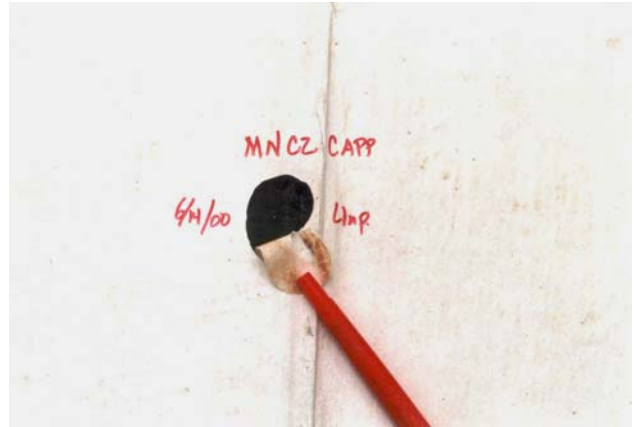
Photo 14: White acrylic coating applied to an asphalt-based membrane, that lacks asphalt emulsion primer, revealed less bond and peel strength. Note only minor traces of asphalt residue on the bottom side of acrylic coating.

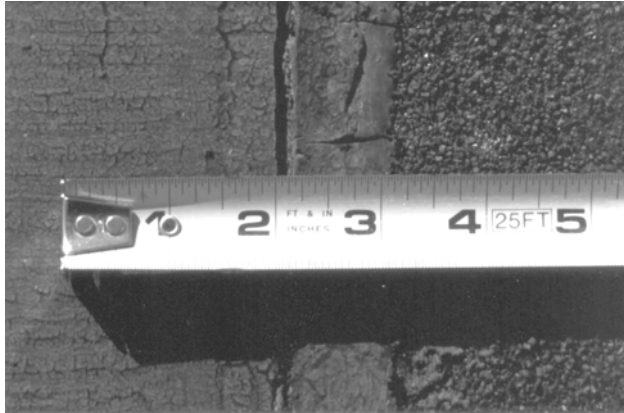
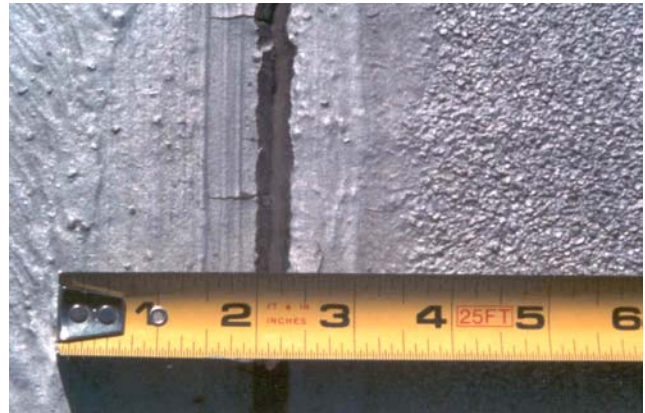
3. The emulsions and aluminum-pigmented coatings have stress-cracked and split directly over the end laps of the polyester-reinforced, SBS and commodity-grade, APP-polymer-modified asphalt membranes, indicating that these membranes are undergoing post application shrinkage (see Photos 15 and 16). However, at test areas where white acrylic coatings were applied over the same polyester-reinforced membranes, no stress cracks or shrinkage were observed in the coating over the end laps of the membranes (see Photo 17). This finding provides reason to believe that the white acrylics are moderating the thermal movement of the membrane, thereby keeping these polyester-reinforced sheets from noticeable shrinkage.

Photos 15 and 16: Stress cracks through emulsion and aluminum coating at end laps of polyester-reinforced, APP-Polymer-modified asphalt cap sheet indicates that membranes are experiencing post-application shrinkage.

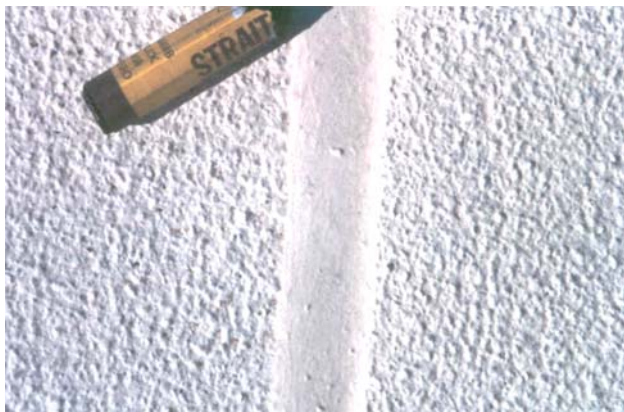
Photo 17: No stress cracks or shrinkage was evident at same SBS polymer modified asphalt cap sheet end laps coated with white acrylic coating.

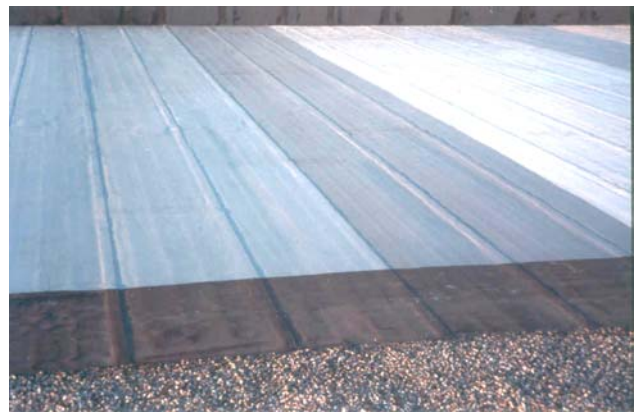
Photo 18: Overview of aluminum-pigmented, solvent-based SBS-polymer-modified and premium-grade coatings, as well as acrylic coatings that are performing well.

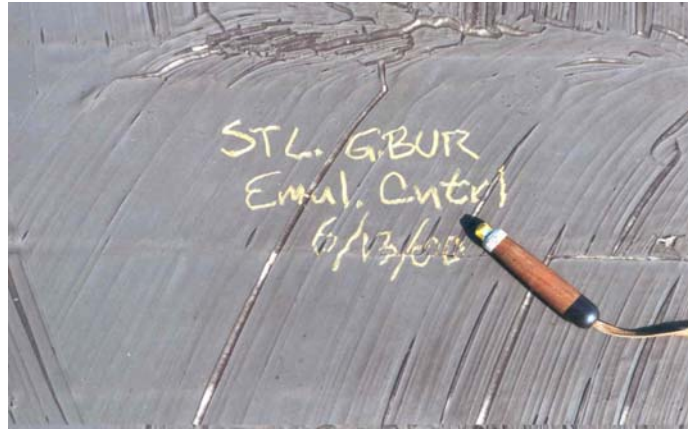
6. The black asphalt emulsion primed areas, which were left exposed as primed control areas, are showing some signs of cracking and erosion. This cracking is most pronounced where the lack of glazing craftsmanship during membrane application allowed the hot asphalt glaze coat to be applied too heavily, thereby promoting alligating of the glaze or "flood" coat of hot asphalt and the overlying emulsion primer (see Photo 19).

5. Hot asphalt glaze coats and asphalt emulsion primer coats applied too thick or heavily will generally craze, crack, alligator and eventually telegraph the cracks through the overlying coating at exposed alligating crack locations. With time, the coatings are eroding along the edges of the cracked underlying asphalt, therefore hindering the long-term adhesion of the roof coatings along the cracks.

Photo 19: Depicts cracking and erosion of exposed asphalt-emulsion primer that was applied over hot asphalt glaze coat that was installed too heavy and is subsequently telegraphing, alligatoring/cracking through the overlying emulsion.
