FIGURING OUT FLASHINGS

ROOFING PROFESSIONALS EXPLAIN THE IMPORTANCE OF THROUGH-WALL FLASHINGS

by Harrison McCampbell, AIA, and Nick Warndorf

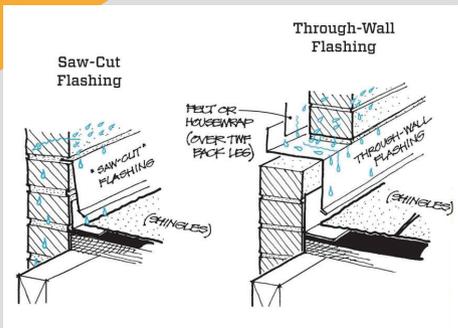
This drawing demonstrates the functions of saw-cut vs. through-wall flashing and the obvious benefits of through-wall flashing. Figure courtesy of Harrison McCampbell, AIA.

The difference between the two types of flashing is a viable through-wall flashing is functional; permanent; and takes just a little more time, sequencing and craftsmanship when being installed. It is designed to extend from the outer wall surface through the exterior wall covering and beyond wall sheathing to be properly lapped by the moisture retarder within the wall cavity.

Saw-cut flashing is designed to be a surface solution that has the appearance of through-wall flashing but is essentially ineffective. Saw-cut flashing is cheaper, requires less labor to install and is deceptive in its ability to control water within the masonry wall. Through-wall flashing directs any water that penetrates the exterior surfaces to run out at the base of a wall; saw-cut flashing allows the same water to run behind the flashing and can continue down within the wall.

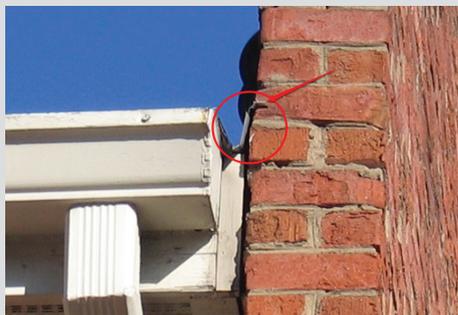
Photo 1: An example of saw-cut rather than through-wall flashing

Photos 1-3 are examples of homes that have received saw-cut rather than through-wall flashing. In Photo 3, there is a concrete second floor patio that ties into a brick wall. In many cases, this concrete tie-in would have been facilitated by wall drainage to a poured slab. Ideally, the slab would be poured with a positive slope away from the house and then be covered with a waterproofing membrane and drainage mat. The slab would have positive slope toward the front of the porch, which ultimately would drain with weeps—drains at the edge of the slab. In addition, it should have been installed at least one course lower.

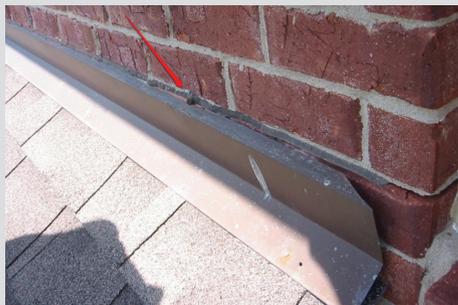
Photo 2: This saw-cut flashing is beginning to pull away from the wall, making it completely ineffective in keeping out water.

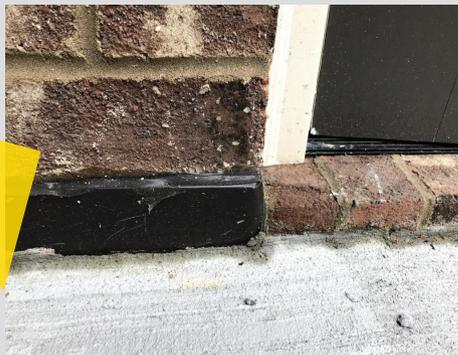
Photo 3: This concrete slab would have benefited from through-wall flashing running under the lower course of brick.

As a final means of drainage, there should be a through-wall flashing that runs under the lower courses of brick, behind the brick exterior wall and up the substrate interior wall with counterflashing facilitated by the house wrap or moisture retarder. Finally, directly above the through-wall flashing and evenly spaced the entire length of the porch wall, there would need to be weep holes, typically at a maximum of every third brick, for any oversaturation of the brick to be allowed to drain along the line of the through wall.

However, the photo shows the installing contractor chose to allow the water to bypass the porch and run down the wall. The porch also had negative slope, allowing water to collect at the inside walls and corners, which, in turn, created cascading water at the brick wall between the brick exterior wall and poured concrete porch. Because of the absence of detailed drawings, one might also assume the same detail exists on the lower porch, which ultimately could create below-grade issues

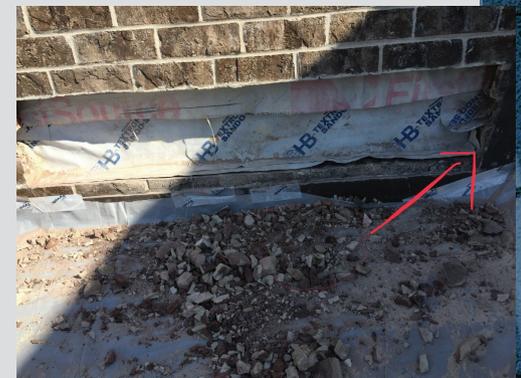
Photo 4: An example of a failure in existing through-wall flashing

Photo 4 shows an example of a job that had a failure in the existing through-wall flashing, which, in this case, was a membrane. To repair this, the length of the existing brick wall to receive the through-wall flashing will need to be removed with enough space to facilitate the proper installation of wall flashing and metal through-wall flashing. The brick can be removed and supported with small masonry jacks to prevent collapse if enough is being removed to compromise the structure. This form of repair is expensive but standard. A critical factor is the interior wall moisture retarder must be properly installed, countering the newly installed metal through-wall flashing so any penetrating water is allowed to run to the edge of the wall. This way, it will not stop short of the edge or outside of the exterior brick wall. This will correct the saw-cut flashing issue and allow proper wall drainage.

In this example, the water test we conducted demonstrated the wall was taking on water at an accelerated rate, the weep holes were not properly functioning and the existing through-wall flashing had failed. However, as

There were, in fact, a number of issues, but the biggest problem was the end dam terminations (corners) were not completely sealed. This is why through-wall traditionally was made from soldered copper. This installation technique ensures the installer's skill is relied upon rather than an adhesive. Self-adhering membranes used as through-wall flashing primarily are meant for unskilled labor and speed of installation rather than attention to detail. All XYZ joints are at a critical failure point, and roofing contractors have to pay attention to every detail if they hope to prevent future errors.
